FAULT ANALYSIS OF GEARBOXES IN OPEN PIT MINE

Original scientific paper

Milan P. Vasić¹, Blaža Stojanović¹, Mirko Blagojević¹

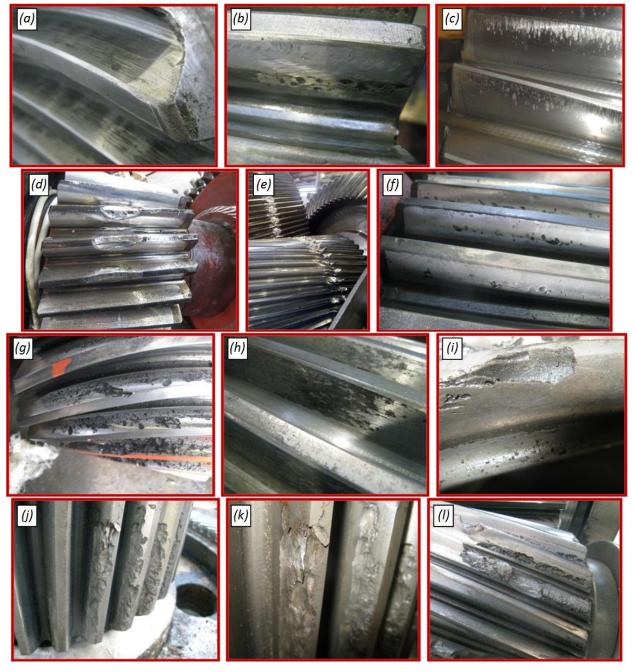
Fig.1. Typical gear failures on analyzed gearboxes

Scuffing occurs on the working surfaces of tooth flankes, most often between the tip and root circle [10]. It is formed as a result of oil film disruption, local metal contact, sudden temperature increase due to friction, local welding and tearing of welded particles [10-13]. It is manifested by the appearance of creases and notches in the sliding direction. An example of pronounced scuffing due to a large deviation in the parallelism of coupled gears axes is given in Fig.1.c.

Permanent deformations occur on the tip, side, and very often on the entire tooth. They are formed as a result of high loading, impact due to the large side clearance, interruption of lubrication which leads to warming and reduction of gear material strength, as well as when foreign particles pass through coupling [10-12]. They are manifested by the appearance of dents, creases or complete reshaping of tooth parts. Examples of permanent deformations due to the presence of chipped parts of other elements in the coupling are given in Fig.1.d and 1.e.

impact on service life, according to ISO 10825 [9], fatigue wear is classified into: initial pitting, progressive pitting (Fig.1.g), micro pitting (Fig.1.h). flake piting (Fig.1.i), spalling (Fig.1.j) and case crushing.

Fatigue cracks (Fig.1.k) result from cyclic loads the intensities of which are most likely lower than the material tensile strength.

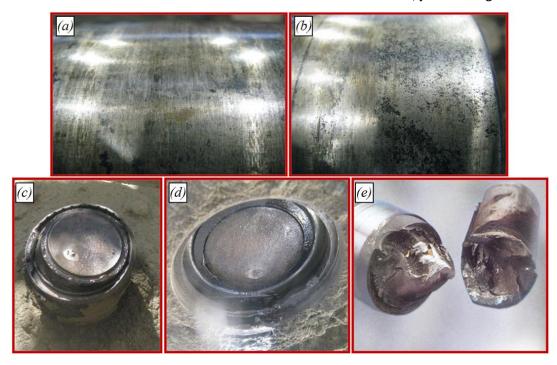
Fig.2. Typical shaft failures on the analyzed gearboxes

Surface deteriorations, shown in Fig.2.a, occur at locations of relative displacement of firmly mounted parts such as bearings, gears, and couplings. They are manifested by the appearance of dark brown spots that represent fretting corrosion (Fig.2.a), as well as by the emergence of clefts in the rotating direction (Fig.2.a) which represents abrasive wear.

Surface fatigue phenomena occur on the stacked parts. They are caused by the relative displacement of elements along the shaft in cycles n times. They are manifested by the appearance of smaller or larger holes, forming a characteristic relief in phases (Fig.2b), as in gears.

Shaft failures most often occur on the input shafts of the worm and bevel gears, which are made as a one piece with the shaft, at places of pronounced discontinuities in cross section sizes. They occur as a result of overloading, plastics deformations or fatigue, and each type of fracture is manifested by the characteristic appearance of the fracture surface [16]. In case of overload, the fracture surface is relatively rough. In case of shaft fatigue fracture, the fracture surface is relatively smooth, and the final fracture is relatively rough. An example of such a fracture is shown in Fig.2.c, and 2.d, where a characteristic rough portion representing the final fracture can be observed, while the rest of the fracture surface is smooth. Bending stress fractures are perpendicular to the shaft axis, just as in Fig.2.c and 2.d, while torsional stress fractures are often set at an angle of 45° to the shaft axis of the, just as in Fig.2.e.

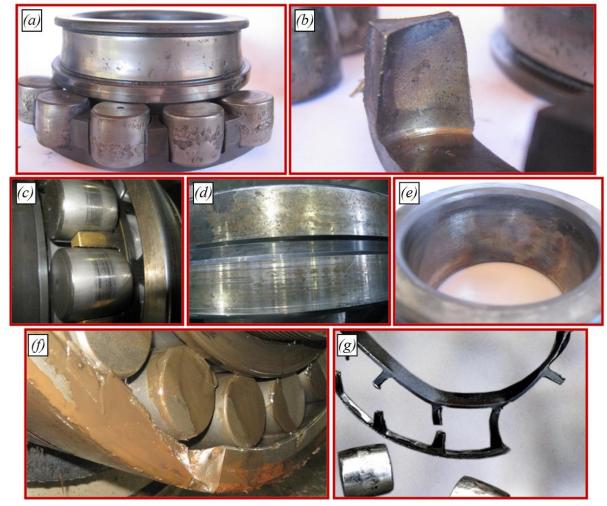
Fig.3. Typical bearing damages on the analyzed gearboxes

Fatigue (pitting) is the result of cyclic stress that develops at the contact surface [11]. It is manifested by the appearance of pits in the initial phase and the destruction of the contact surface in the final phase [19-21], creating a characteristic relief, as in gears and shafts. An example of pitting on a double-rowed roller bearing is shown in Figu.3.a, while Fig.3.b shows an example of pitting on a bronze cage of a roller bearing.

cavitation of the lubrication inlet pipelines [21]. They are manifested by damaging the contact surfaces in the form of notches (Fig.3.c), grooves and scratches.

Oxidation corrosion is caused by the presence of moisture. It is manifested by the appearance of oxide coatings of different thicknesses and colors: thin - relatively light (<40 μm), medium - light brown and gray (<500 μm), as well as thick - usually dark coatings (>500 μm) [11]. As the thickness of the oxidized coatings increases, they burst and are removed from the surface, leaving a relief surface. An example of oxidation corrosion on the outer bearing ring is shown in Fig.3.d.

Fretting corrosion occurs when there is a gap between the shaft and the inner ring or housing and the outer ring [19-21]. The gap allows for the relative displacements of the aforementioned parts resulting in chipping of small particles of material. It is manifested by red oxide coatings or black coatings in the presence of oil or borax peroxide (rust) coatings in the presence of moisture [11]. An example of fretting corrosion on the inner bearing ring is shown in Fig.3.e.

fatigue [19-21]. They are manifested by the loss of material from the damaged element surface. Overload fracture is usually caused by rough handling (impact) when the bearing is mounted or dismantled (Fig.3.f), by use of inadequate tools during mounting, or when the bearing is hammered onto an incorrect shaft diameter. Fatigue fracture occurs at sites where surfaces have already been affected by pitting. In this case, cracks continue to grow until complete fusion and final fracture of the element. An example of cage material fatigue fracture is shown in Fig.3.g.

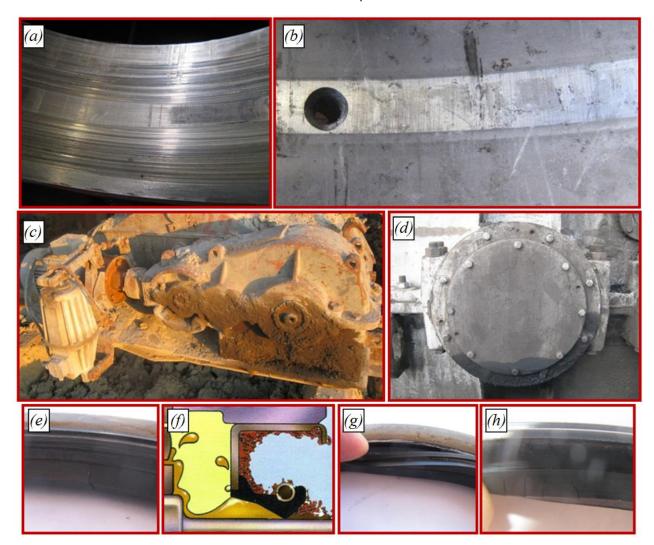
Fig.4. Typical housing failures on the analyzed gearboxes

Sealing failure occurs on the cuff seals, the thin layer of sealant between the housing and cover, and due to insufficient tightening of cover screws [16]. They are manifested in many ways. Fig.4.d shows an example of oil leak due to the sealant failure on the side cover. Fig.4.e shows an example of notched rubber lining when mounted on a shaft with a wedge groove. Also, during mounting, the spring that presses the rubber lining may be damaged or may come out of its groove. Sometimes it is improperly set as shown in Fig.4.f. Excessive exposure to high temperatures causes rubber to harden and crack, as shown in Fig.4.g. Also, during exploitation, the rubber liner can separate from the tin L profile (Fig.4.h), which also causes oil to leak.

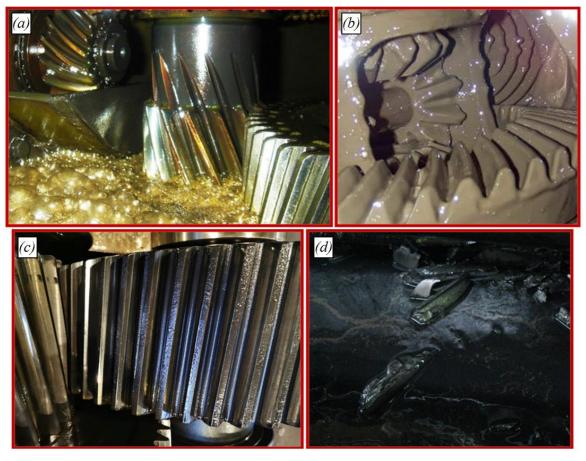
Fig.5. Typical lubricant problems

Oil foaming occurs due to the application of inadequate viscosity oil, due to the low or too high oil level, air penetration, mixing oil with another oil of different viscosity, oil contamination with dust and water [23]. It is manifested by the appearance of small air bubbles on the lubricant surface. Formed impedes foam oil temperature maintenance, accelerates oxidation processes and stimulates aeration, which results in intense cavitation, poor lubrication, and reduced service life of the oil itself. An example of oil foaming in a cylindrical bevel gearbox is shown in Fig.5.a.

An example of chipped teeth in oil is shown in Fig.5.d.

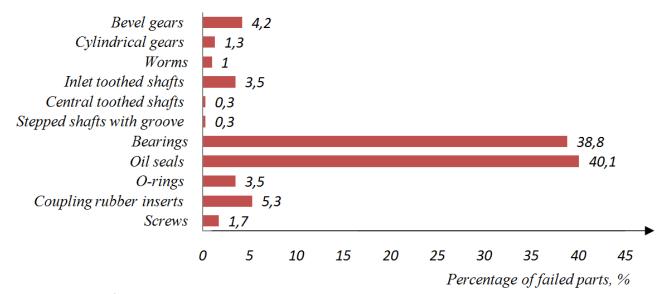
Fig.6. Percentage of occurrence of various types of failures on the tested gearboxes

show that failures are the most likely to occur on oil seals (40.1%), whether cuff seals or a thin layer of sealant, as well as on bearings (38.8%), Fig.6. If oil leakage is minimal or does not require greater amounts for topping, the gearbox will operate under such conditions until the failure of another element that would require total shutdown. As a result of incomplete sealing, water, dust, and other undesirable particles penetrate the inside of the gearbox.

In addition to bearings, a number of failures occurred on gears: bevel (4.2%), cylindrical (1.3%) and worm (1%), as well as on shafts: inlet toothed (3.5%), central toothed (0.3%) and stepped with groove (0.3%), Fig.6. Almost all of these gears, except one cylindrical, failed at the inlet of the gearbox, as expected. The highest rpm is at the inlet, usually 1000, 1500 min⁻¹. There are the highest temperatures and the greatest shocks at startup as well. Gear failures are most commonly manifested by pitting, spalling, tooth fractures and permanent deformations. All this results in an increase in vibration and noise.

The third group of elements consists of failures of coupling rubber inserts (5.3%), screws (1.7%) mounted on covers, Fig.6. The consequences of failure of these elements are far less.

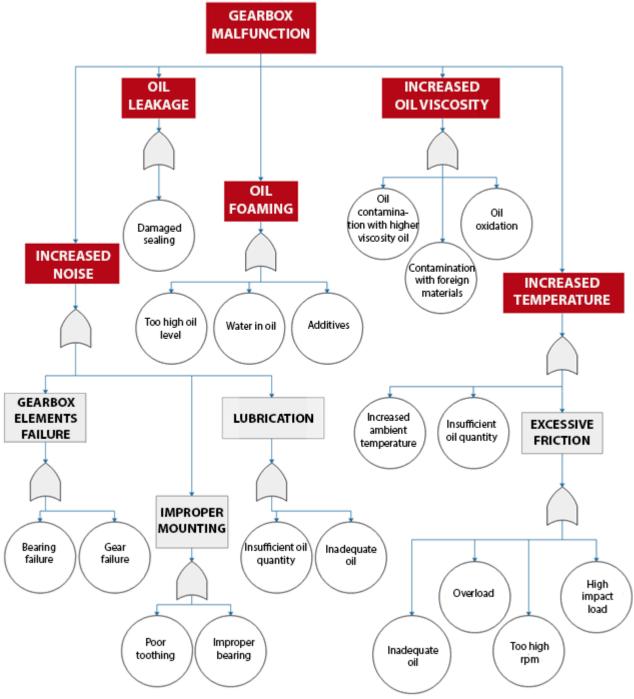
Fig.7. Fault tree of analyzed gearboxes

One of the most suitable methods for analyzing the most likely causes of gearbox failure is the Fault Tree Analysis, which is shown in Fig.7. The unwanted, top event, defined as "gearbox malfunction" may be complete or partial. If the gearbox loses its function, the malfunction is complete. On the other hand, if the gearbox works but its performance is significantly impaired, then the malfunction is partial.
