INVESTIGATION OF POSSIBLE CAUSES FOR APPEARANCE OF A CRACK IN THE WELDED JOINT OF THE SHIP WINCH FRAME

Miloš M. Matejić¹, Ružica R. Nikolić^{1, 2,*}

An appearance of a very unusual crack in the ship winch frame, which happened during the FAT, is described in this paper. The simulation by the FEM was performed to obtain the stresses at which the crack appeared. The possible causes for that crack appearance are considered. Some measures for reducing appearance of such cracks to a minimum are proposed, as well as certain directions for further research of this problem.

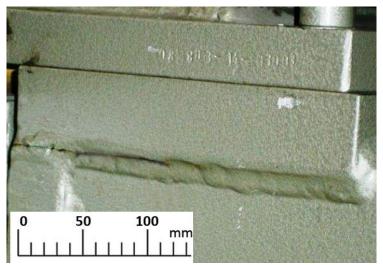
were detected with this probe. Finally, the finishing protection and painting of the frame were done. The final operation of the FAT was mounting of the winch onto the FAT station. During the testing, a crack was noticed at the place where the carrying plate is connected to the device for proper winding-up of the rope, Figure 2.

The crack appeared at a point which is not subjected to the maximum load intensity. It appeared in the middle of the weld, what is a very rare case, both in exploitation and in tests. The crack length was about 120 mm. If the crack has opened completely, that would cause fracture of the system for rope guiding around the winch. Flaws of this type could lead to catastrophic consequences during the winch operation at open seas. Due to appearance of this crack, the safety of the winch operator would be automatically compromised, as well as pulling up or lowering down the cargo and the total failure of the winch would be immanent.

Fig. 2. Crack in the middle of the welded joint – Failure at FAT. (full colour version available online)

In order to avoid appearance of such cracks in the future, it is necessary to introduce the following measures:

1. Cleaning of surfaces prior to welding and their degreasing at the highest quality level;

2. Checking of the protective gas bottle and pressure of the gas in it, and

3. Changing of the welding wire supplier.

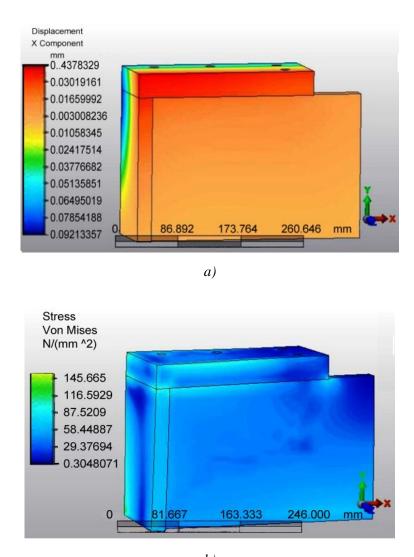
b) Fig. 4. Results of FEM simulations: a) displacements; b) Von Mises stresses. (full colour version available online)

From Figure 4 a) one can see that the largest displacement, during the force action, amounts to 0.04 mm. This zone of displacements is shown in red and it is in the zone of the crack. Value of this displacement is at least four times less than the maximum allowed value, what would imply that this displacement is within the elastic region. Thus, this could not have been the reason for the cracking of the weld. From Figure 4 b) can be seen that the highest stresses in the winch frame act in the region of the crack. They are shown with light blue color and amount to 120 N/mm². The value of stress in that zone is more than four times lower than the allowed value, what would imply that even after the large number of repetitions of the operational cycles of the winch, no crack whatsoever should appear. The much higher stress (over 300 N/mm²) appeared in another part of the model, which is not shown in Figure 4 b), since it does not have effect on the weld and the crack appearance in it.

Thus, the FEM simulation has confirmed the design calculations, what implies that the design errors could be excluded as possible causes for appearance of the weld crack.
