RESEARCH OF THE POSSIBILITY OF REPAIRING BROKEN LAMINATED SPRINGS OF FREIGHT WAGONS BY WELDING

Dragan Petrović, Milan Bižić
petrovic.d@mfkv.kg.ac.rs, bizic.m@mfkv.kg.ac.rs

*University of Kragujevac, Faculty of Mechanical and Civil Engineering in Kraljevo,
Dositejeva 19, 36000 Kraljevo,
SERBIA*

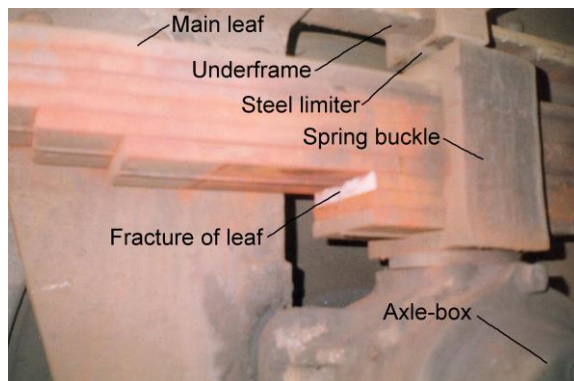
Figure 2. The example of fracture of leaf of LS

Statistical analysis shows that among the most dominant failures of the suspension system are fractures of elements of LS [9]. Among them, the most common are fractures of leafs (Fig. 2), and especially of main leafs. The frequent fractures of leafs caused derailments in many cases [10]. The consequences were huge material damage and significant decreasing the efficiency of railway transportation. All this has disturbed the stable operation of the entire system of thermal power plant. The problem of fractures of LS is usually solved by replacing the entire LS with completely new, or by changing the broken leaf with completely new leaf. Because of frequent fractures, this required a huge funds for the maintenance and purchase of new leafs and LS, which caused decreasing the efficiency and profitability of rail transport. Research of these problems leads to the aim to reduce the enormous costs of maintenance of wagons and it is realized in two directions. The first direction was implied improving the

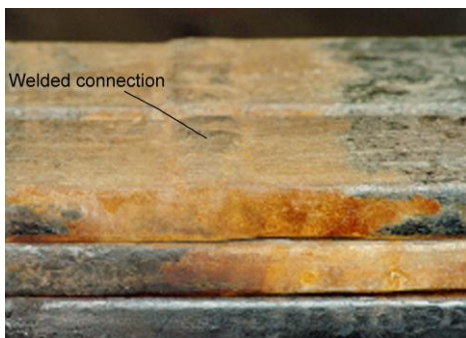
The basic idea of repairing of LS implies that its broken leaf is welded in the place of fracture, with aim of preservation of overall designed geometry and function (Fig. 3). One of the most important segments necessary for the successful realization of this idea was troubleshooting welding technology. This research is realized by the company “Termoelektro”, Belgrade, Serbia. The technology is intellectual property of the mentioned company, and it is not the focus of this paper. The main segments of welding technology are related to the physical, chemical, metallurgical and technological aspects of welding of broken leaf. The technology prescribes the election of welding electrodes, procedure for disassembling of LS, preparation of surfaces for welding, procedure of welding, etc. Based on this technology, two characteristic damaged LS in factories “Gibnjara” (Kraljevo) and “Želvoz” (Smederevo), Serbia, are repaired. In the aim to explore their behaviors and characteristics, these LS are subjected to the experimental tests.

Figure 3. The welded connection of the main leaf

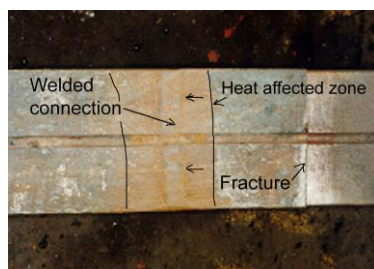
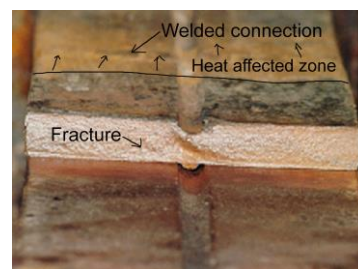
Figure 11. The fracture of LS 1 (left) and LS 2 (right) outside the zone of welded connection

In experimental tests of both LS with welded leaves it was concluded that fracture did not occur in the zone of welded connection or heat affected zone. These extremely important results are shown in Fig. 11.

As expected, it was concluded that in these fatigue tests have not reached the expected lifetime of LS. The reasons for this lie primarily in the inadequate quality of embedded material, as well as in the increasing of static stress during the exploitation and in the aforementioned experimental tests. Poor quality of material is caused by the presence of chemical impurities, as already noted in previous researches [16].
