Fracture Analysis of the Hydraulic Truck Crane ATLAS 3006

Keywords: Hydraulic truck crane, Truck crane boom, Fracture analysis, FEM analysis

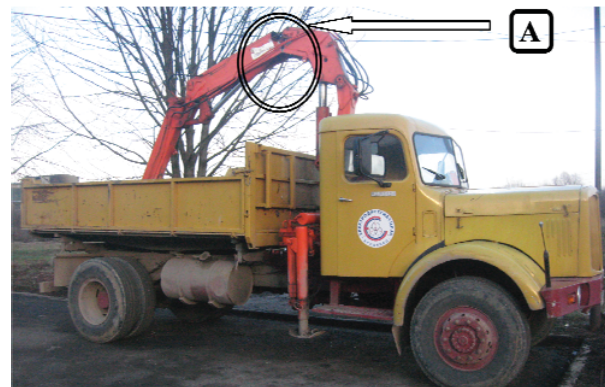
After more than 12 years of crane exploitation, during a regular overhaul, certain damages at the first jointed segment of the crane were noticed. This damage is at the point of connection between the hydrocylinder and the segment (detail "A" - Figure 2).

Figure 2. Point of the fracture initiation in the crane Atlas 3006

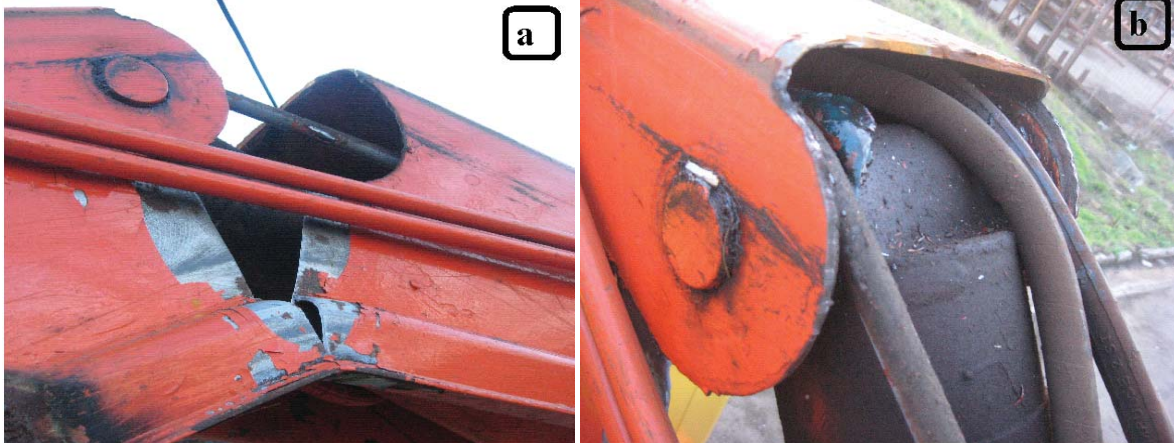
For the purpose of saving, the user himself, without any previous detailed analysis of the causes of damage, solved the problem of repairing the damage in the truck crane boom by welding at the point of cracking. The damaged

plates were connected by butt welding. After the repair, the crane was returned to exploitation.

After more than 3 years of exploitation of the repaired crane, a fracture (Figure 3) occurred at the point where it had been repaired.

Figure 3. Point of the boom fracture in the telescopic truck crane ATLAS KRAN 3006 a) lateral side; b) upper side;

The fracture analysis clearly shows the fatigue fracture initiation which occurred in the transition zone between the weld and the base material as well as at the point of joining the plates with a large difference in thicknesses (Figure 3).

- The truck crane boom was not repaired in a prescribed and adequate manner. Such jobs should be entrusted to the companies which are specialized for that type of activity.

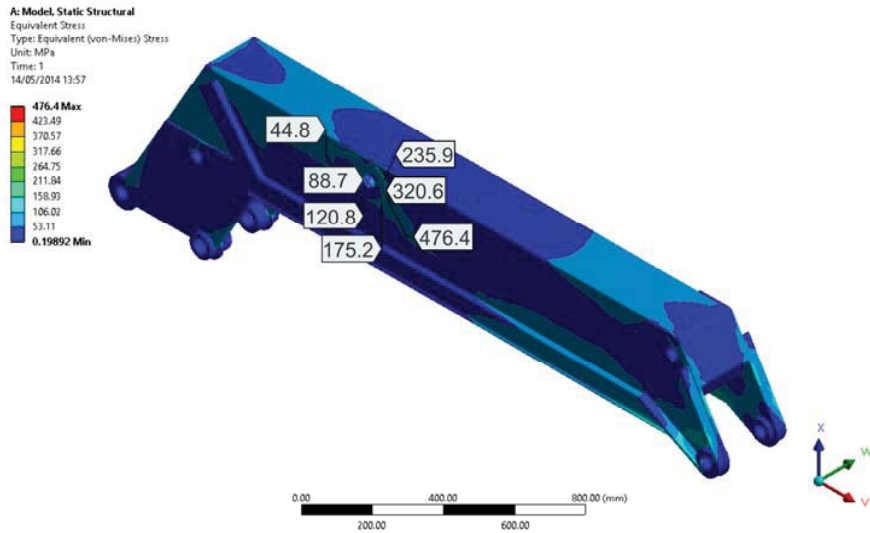
Figure 8. Stress state of the first segment of the boom with characteristic values

Measuring point	1	2	3	4	5	6	7
$s_{i,max}$ (MPa)	476.4	320.6	235.9	175.2	120.8	87.7	44.6
$s_{i,min}$ (MPa)	428.8	288.5	212.3	157.7	108.7	78.9	40.1
s_{mean} (MPa)	381.1	256.5	188.7	140.2	96.6	70.2	35.7
s_a (MPa)	47.6	32.1	23.6	17.5	12.1	8.8	4.5

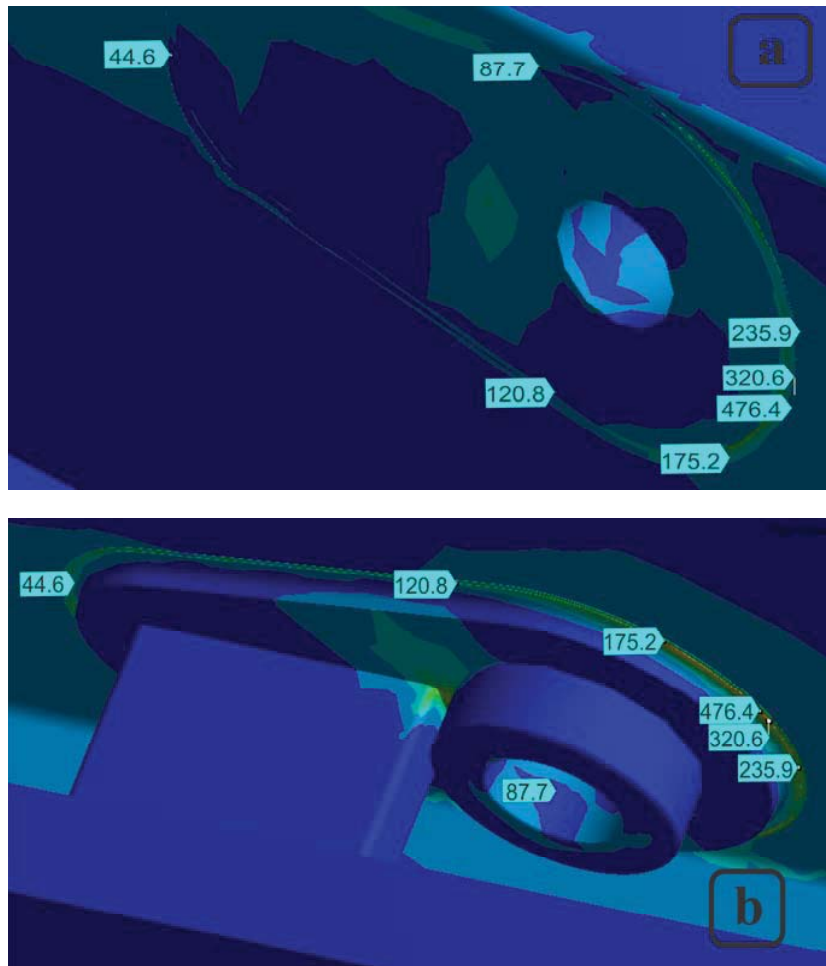
Figure 9. Stress state at the point of connection between the hydrocylinder and the first segment:
a) outer side b) inner side

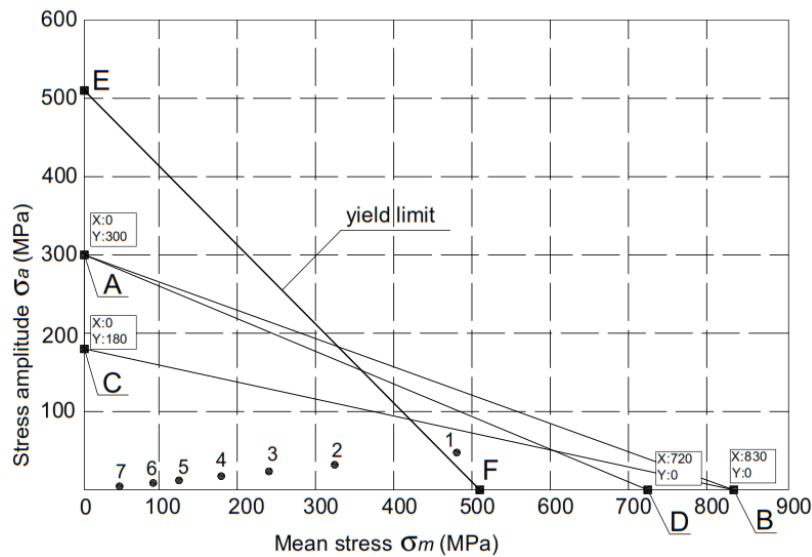
Figure 9. Goodman diagram in the weld zone

In Fig. 9, the mentioned points (1-7) are below the line A-B, which represents the fatigue boundary, while in Fig. 10 the point 1 exceeds the fatigue boundary and thus fatigue safety is not provided.

The line C-D was chosen to be the relevant fatigue line and in the first diagram in Figure 3.9 the point 1 does not exceed this boundary, but in the diagram in Fig. 10 this boundary is already exceeded in terms of the position of the point 1 in the diagram.

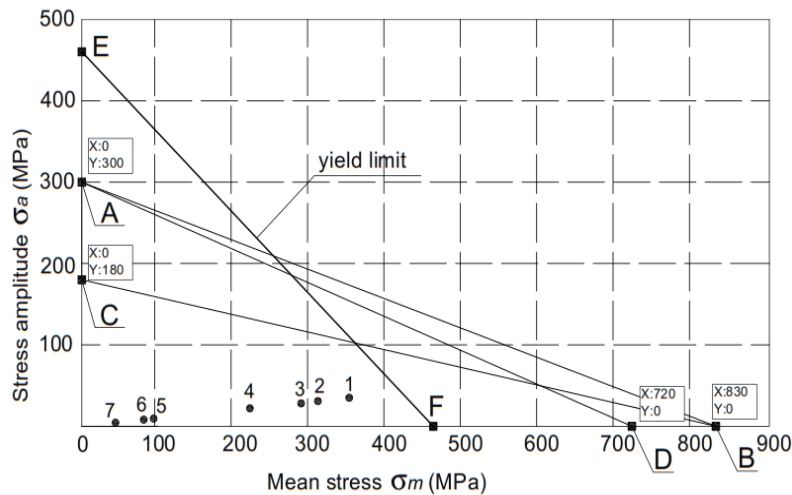
Figure 10. Goodman diagram for the base material

- The critical value of stresses in the weld exceeds the fatigue boundary line. Therefore, fatigue failure

safety is not provided, which was proved by the FEM analysis.
