DEGRADÁCIA KONŠTRUKČNÝCH MATERIÁLOV 2013

DETERMINATION AND ANALYSIS OF CAUSES FOR A CATASTROPHIC FAILURE OF A RESPONSIBLE MACHINE PART

Vukić Lazić¹, Srbislav Aleksandrović¹, Ružica R. Nikolić^{1,2}

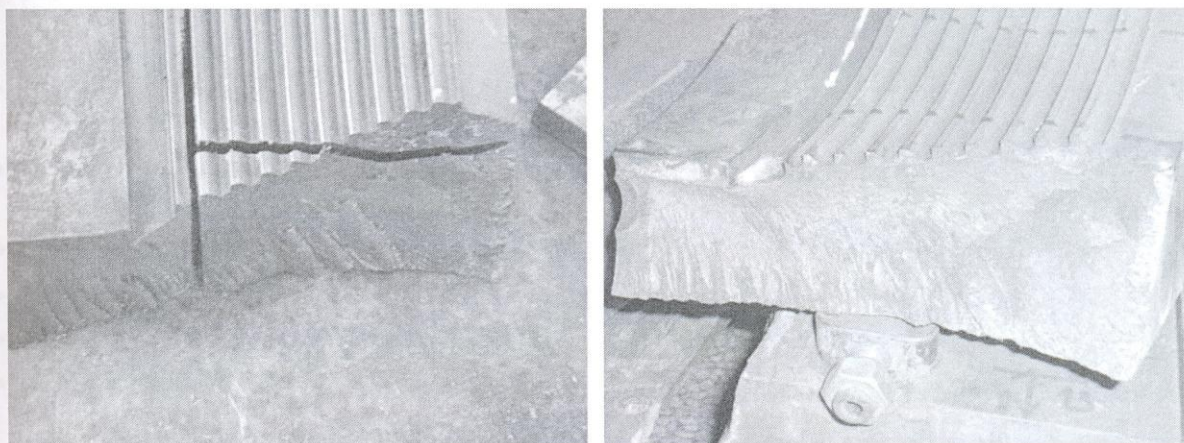
Fig. 2 Appearance of some fracture surfaces of the broken part

- Depth and quality of the nitrided layer satisfied the demanded requirements;
- Macro investigations of the fracture surface provided the conclusion that its appearance belongs to a class II for estimate of the stripeneness of fracture, level 5 (wood-like fracture);

- Semi-finished forged pieces that have stripe-like fracture of levels 4 and 5 are discarded as rejects;
- Microstructure satisfies requirements for the tempered state of steel;

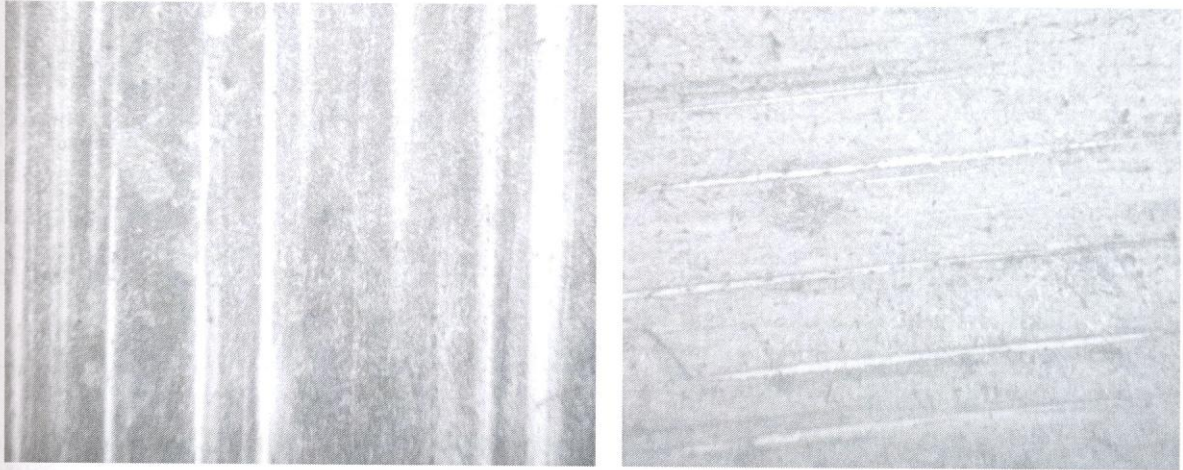
Fig. 4 Microstructure of metallographic ground samples from different fracture zones (200x)

- Absorbed impact energy at – 40°C does not satisfy requirements of the original steel;
- Metallographic analysis of the fracture surfaces, on a sample with the impact energy of 6 J at – 40°C (Table 6 – sample 5) showed segregations of phosphorus over 1/3 of the surface (Figure 4);

- Presence of phosphorus segregations in microstructures at ten plate-samples taken from different places in the fracture zone, points to the fact that material was of the unacceptable quality, since those inhomogeneities in material increase its brittleness.
