BOŠNJAK S, ARSIĆ M, SAVIĆEVIĆ S, MILOJEVIĆ G, ARSIĆ D. Fracture analysis of the pulley of a bucket wheel boom hoist system. *Eksploatacja i Niezawodność – Maintenance and Reliability* 2016; 18 (2): 155–163, <http://dx.doi.org/10.17531/ein.2016.2.1>.

FRACTURE ANALYSIS OF THE PULLEY OF A BUCKET WHEEL BOOM HOIST SYSTEM

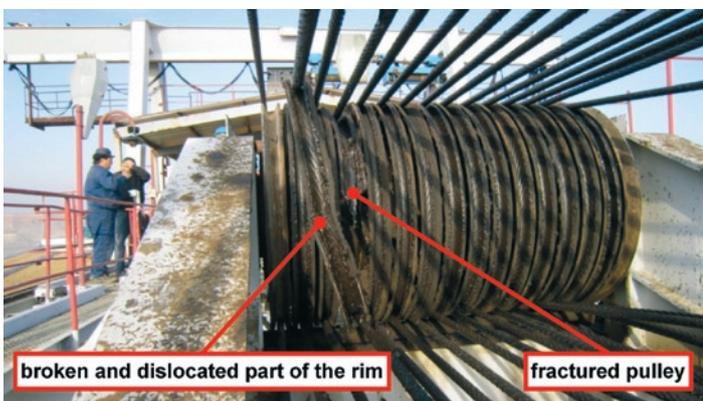
Fig. 2. Fracture of the pulley of the fixed pulley bloc

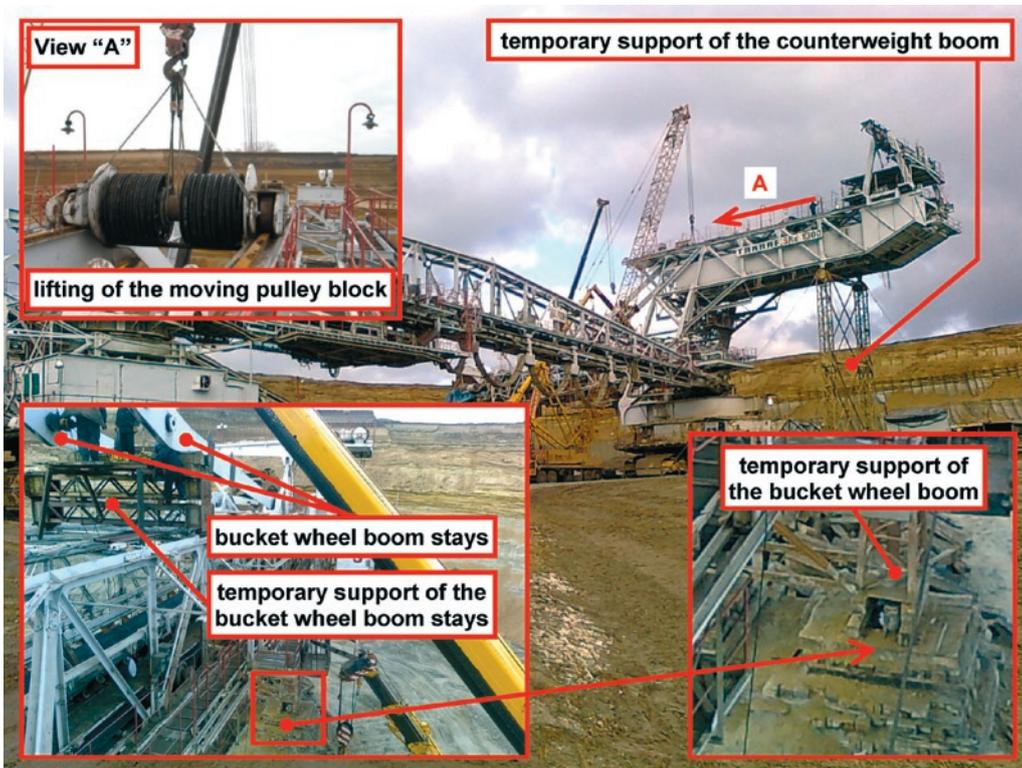
supporting of the machine, dismantling of the BWE hoist system, testing and repair of the failed pulleys, testing of the rope and reassembling the BWE hoist system (Fig. 3, Table 1).

Fig. 3. Details of the BWE temporary supports and the dismantling of the BWE hoist system

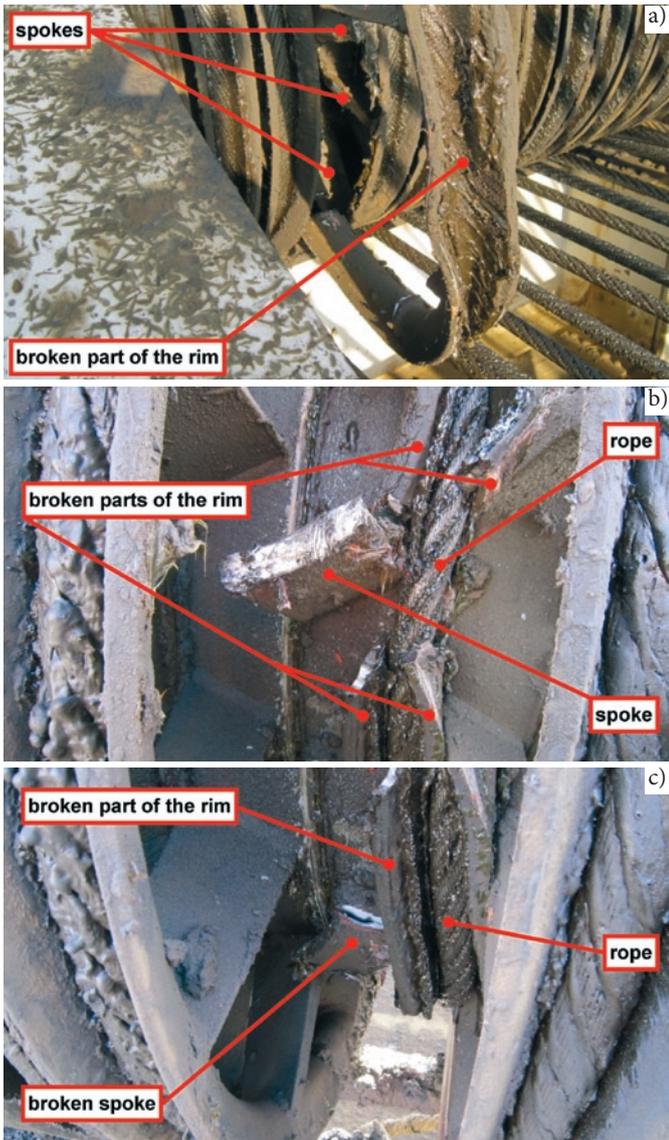
During BWE exploitation a failure of the welded joints of the spokes and rim occurred, which led to the plastic deformation and fracture of the rim (Figs 4a, b). Apart from that, plastic deformations of the spokes are observed (Fig. 4c) as well as fractures of their welded joints with the hub.

Fig. 4. Details of the fractured pulley: (a) front view; (b) back view; (c) view from below

Based on the presented results, it was concluded that the pulley fracture was caused by the ‘manufacturing-in’ defects. That is why it was decided to carry out the repairs of the pulley spokes’ welded joints, without modifying their design.

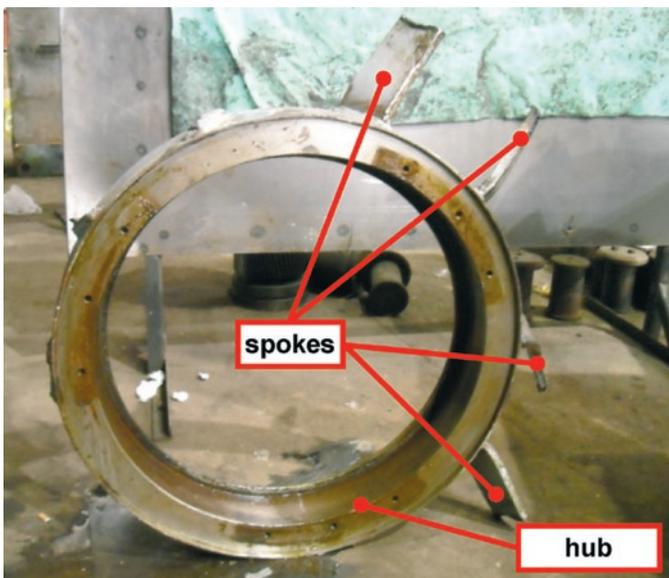
Fig. 5. A part of the damaged pulley used for sampling

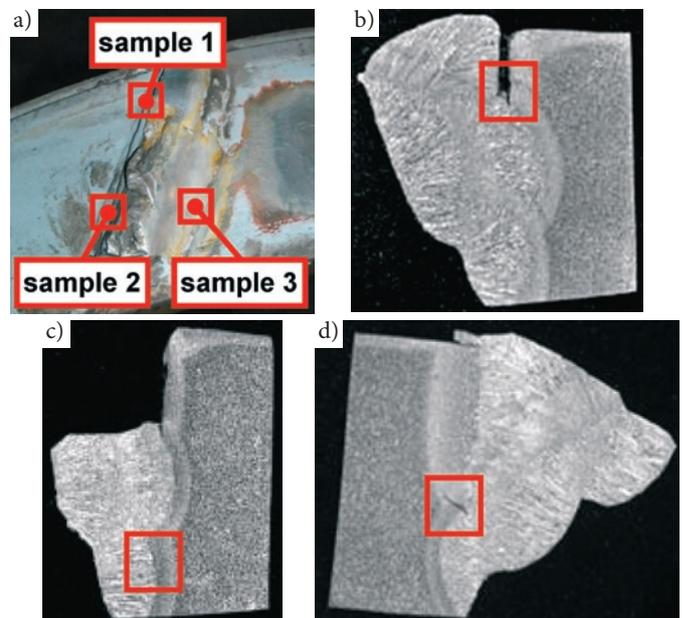
Fig. 6. Sampling zones (a) and samples: 1 – (b), 2 – (c), 3 – (d)

taken from the welded joint of the spoke and hub (Fig. 6). Grain sizes were determined using the standard [19], and the content of the non-metallic inclusions according to the code [20] (Figs. 7, 8).

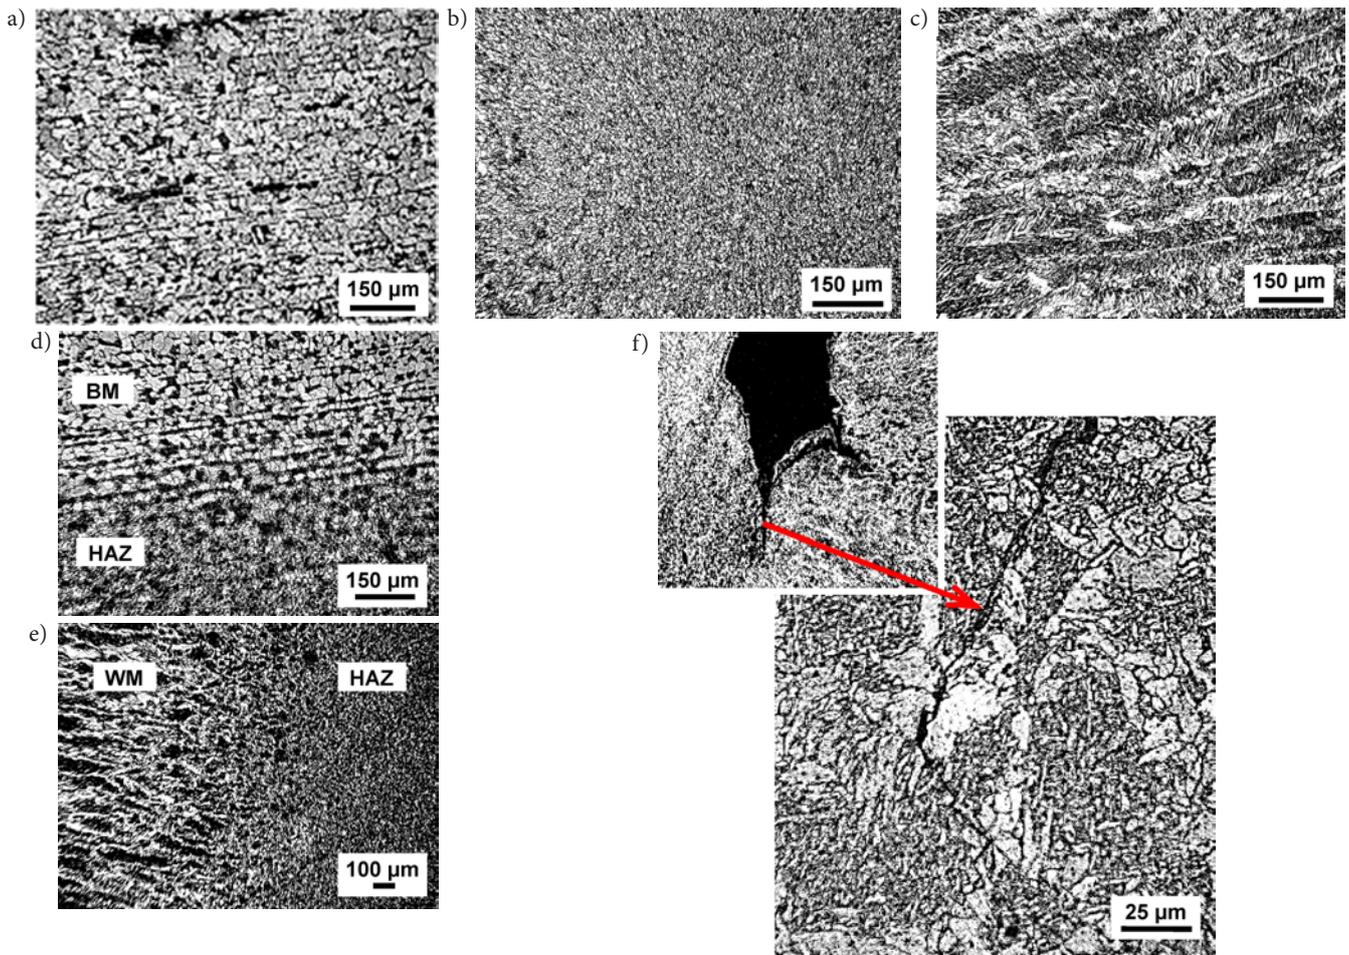
Fig. 7. Sample 1 (etched with 3% nital): (a) strip-type ferrite-pearlite microstructure of the BM, microhardness of 140–144 HV1 [27]; (b) fine-grained ferrite-pearlite microstructure in HAZ, microhardness of about 159 HV1; (c) casting dendritic microstructure of the WM, microhardness of 172–197 HV1; (d) microstructure on the verge of the BM and HAZ; (e) microstructure on the verge of the WM and HAZ; (f) tip of the crack (depth ≈ 4 mm, width ≈ 0.5 mm) and its propagation

Micrographic testing indicates the notably structural heterogeneity of the welds. BM has the strip-type ferrite-pearlite microstructure with non-metallic inclusions of both oxide and sulfide type (Fig. 7a). The microstructure in HAZ (Fig. 7b) is fine-grained ferrite-pearlite with fine-grained oxide type non-metallic inclusions. WM has the casting dendritic microstructure (Fig. 7c) because the appropriate heat treatment of the pulley welded structure was not carried out. Under fatigue loading the non-metallic inclusions in BM and HAZ may cause the appearance of initial cracks, whilst the dendritic microstructure of the WM indicates the tendency towards the brittle fracture. Poor manufacturing practice led to multiple welding defects – incomplete welding (Fig. 6b). Those defects significantly accelerate premature crack initiation by playing a role, from the welding point of view, as the local HAZ based weak link.

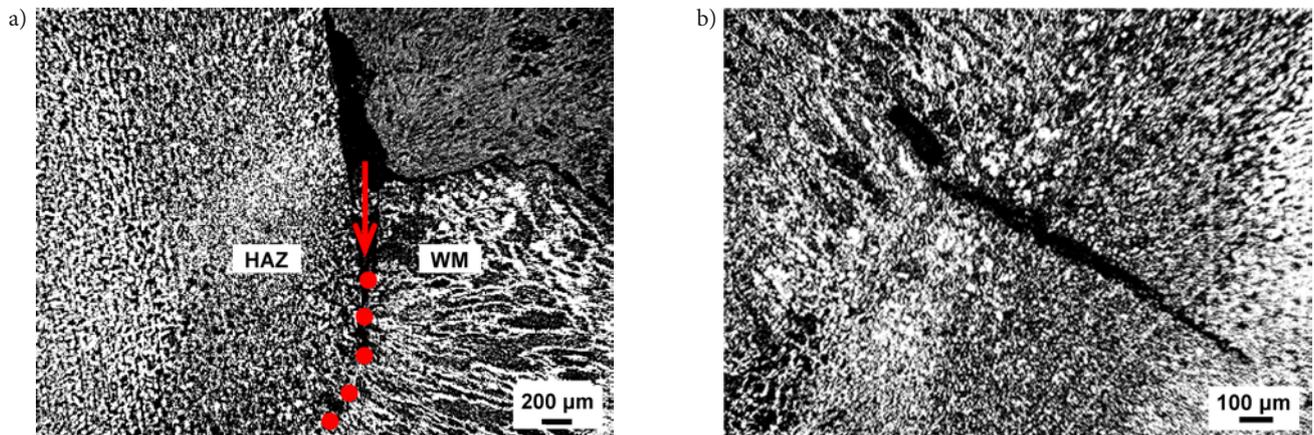
Fig. 8. (a) Crack propagation alongside the verge of the WM and HAZ, sample 2 (framed detail in Fig. 6c); macrocrack (total length of ≈ 1.5 mm) initiated in WM and its propagation through HAZ and BM, sample 3 (framed detail in Fig. 6d)

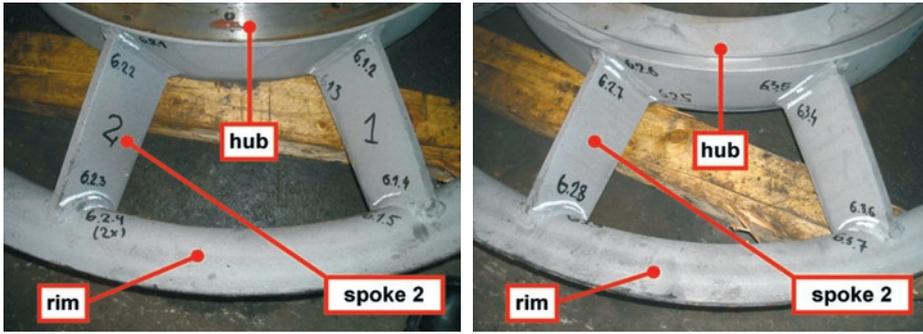
observed on all pulleys. They are considerably more pronounced on the welded joints of the spokes and rim than the welded joints of the spokes and hub.

Fig. 9. Typical MPI indications – pulley 6, spoke 2: (a) left side; (b) right side

Designation (a.b.c*)	6.2.1	6.2.2	6.2.3	6.2.4	6.2.5	6.2.6	6.2.7	6.2.8	6.2.9
Figure	9a				9b				
Length (mm)	15	30	80	20;30	25	30	40	100	55

The considerably more pronounced presence of the MPI crack indications at welded joints of the spokes and rim is the consequence of their geometry being more complex than the geometry of the welded joints of the spokes and hub.

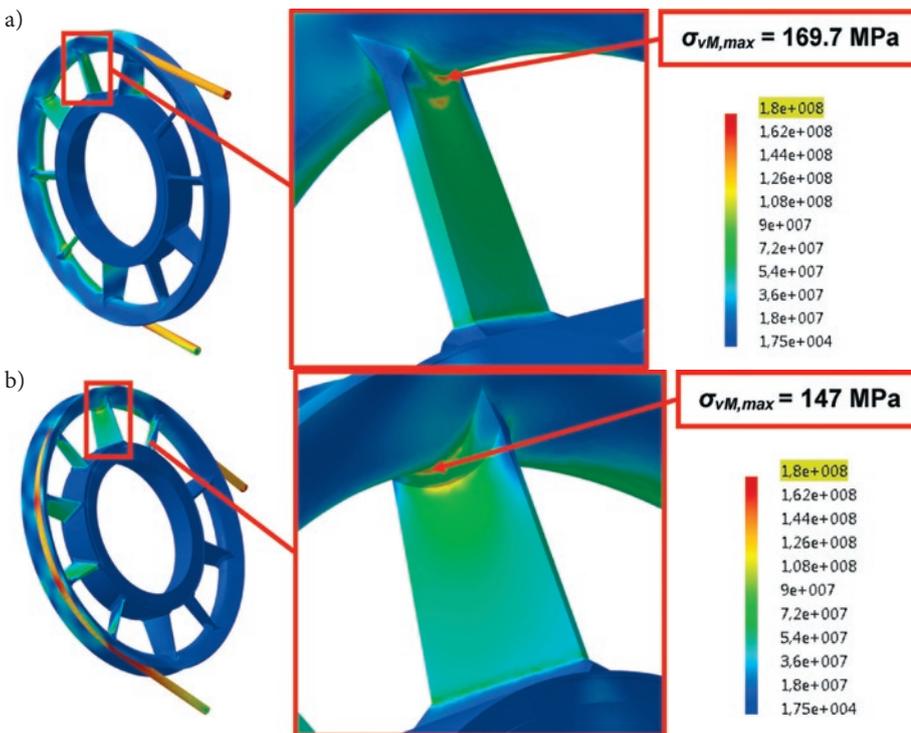
rope and the pulley was simulated by contact connection. Maximum values of von Mises stresses are obtained in the T-fillet welded connections of the rim (Fig. 15). The characteristic stress levels of the pulley load cycle during excavation for both considered LCs are presented in Table 7. For the maximum rope force (209.1 kN, Fig. 11) ob-

Fig. 15. The von Mises stress field obtained for $F_R = 191$ kN (the maximum rope force in LC HZ, Fig. 12)

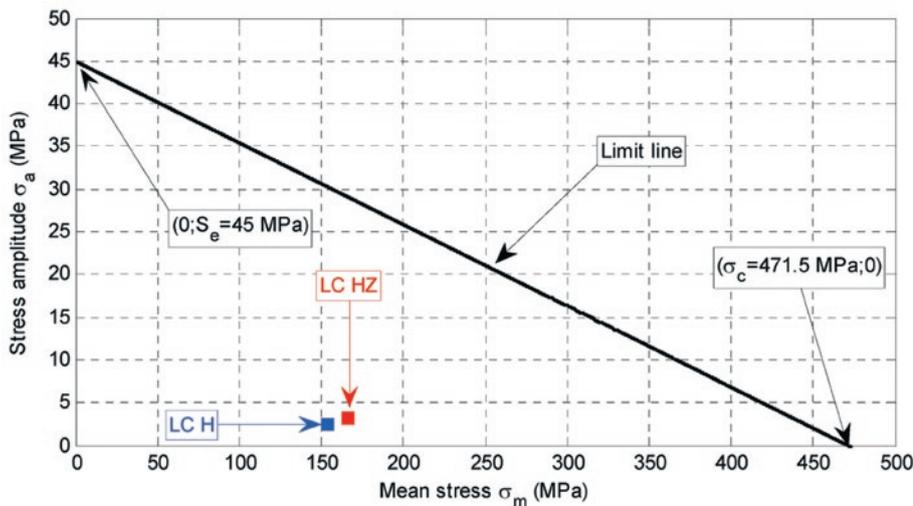
Fig. 17. The modified Goodman diagram

It is obvious (Fig. 17) that in both representative LCs the combinations of the mean stress and the alternating stress in the critical zone (Table 7) lie considerably below the limit line connecting the fatigue limit S_e and the tensile strength of the weld metal σ_c . Besides that, in the case of the maximum rope force obtained by using code [12], the maximum von Mises stress value ($\sigma_{vMmax,[12]}$) is 2.5 times lower than the tensile strength of the weld metal (σ_c , Eq. (1)).
