EFFECT OF ELEVATED TEMPERATURES ON MECHANICAL PROPERTIES OF ULTRA HIGH STRENGTH HOT WORK TOOL STEEL H11

Summary

Key words: H11 steel, elevated temperatures, tensile test, strain hardening, FEM

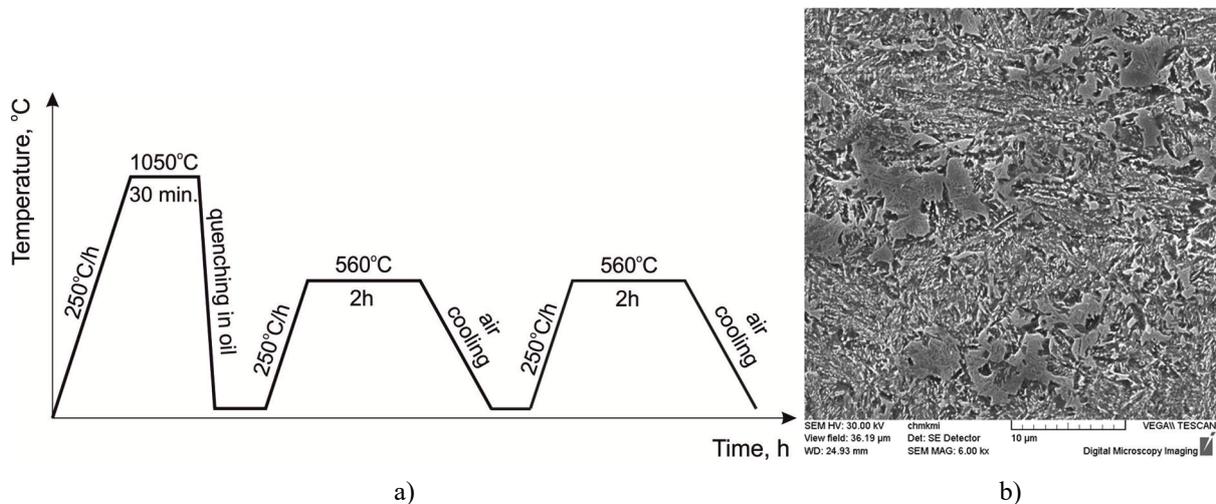
Fig. 1 Heat tretment cycle (a) and specimen microstructure (b)

geometry due to wear, micro-chipping, thermal-cracking or breakage. So, it is crucial to determine the optimal heat treatment regime [16, 17]. The prepared plate was heat treated according to the proposed regime. The heat treatment technology assumed quenching and tempering at specific temperatures in order to obtain certain mechanical properties and structure, i.e. the same as properties of forging tools in the production process. The heat treatment regime was as follows (Figure 1a):

- heating up to 1,040 °C, holding on that temperature for 1 hour and then quenching in oil cooled to room temperature. The obtained hardness was approximately 55 HRC.
- double tempering; first at 560 °C, holding for 2 hours and then taking the samples out of the furnace and cool in the air; after the first phase with single-tempered samples is completed, repeating the first tempering cycle.

The SEM micrograph of the tested steel is shown in Figure 1b. The SEM specimen was made from the same plate that was used for the preparation of the tensile specimens. It can be noticed that the whole specimen consists of tempered lath martensite. Tempered martensite is the expected microstructure for this class of steels since that structure has a high resistance to initiation and propagation of cracks and at the same time it exhibits high hardness. Also, no inclusions or defects which could affect the test results were detected in the structure. Defects usually have phosphorus or sulfur origin or there can be carbide particles, which, when grouped or having become larger, can have a significant impact on tensile properties of steel. This is especially the case when defects are larger than 0.1 mm [18].

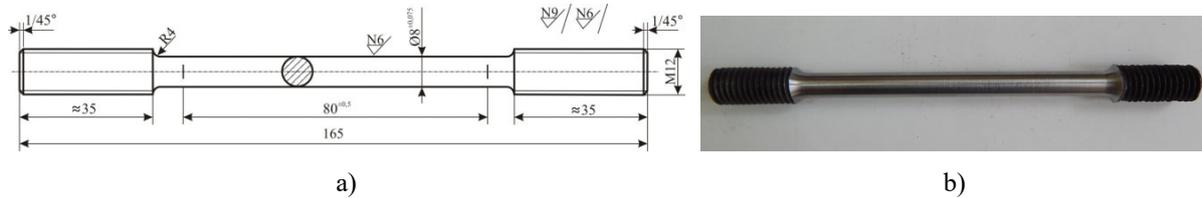
Fig. 2 Tensile testing sample: drawing (a) and real sample (b)

The specimens were cylindrical and were prepared according to appropriate standards [22]. A drawing of the specimen and one prepared real specimen are shown in Figure 2. The experimental determination of mechanical properties at elevated temperatures was performed on a universal testing machine Zwick Roell Z100 equipped with a special furnace for specimen heating (Figure 3). Two test specimens were prepared for each testing temperature. The tests were conducted at 20 °C, 300 °C, 400 °C, 500 °C, 600 °C, 650 °C, and at 700 °C.

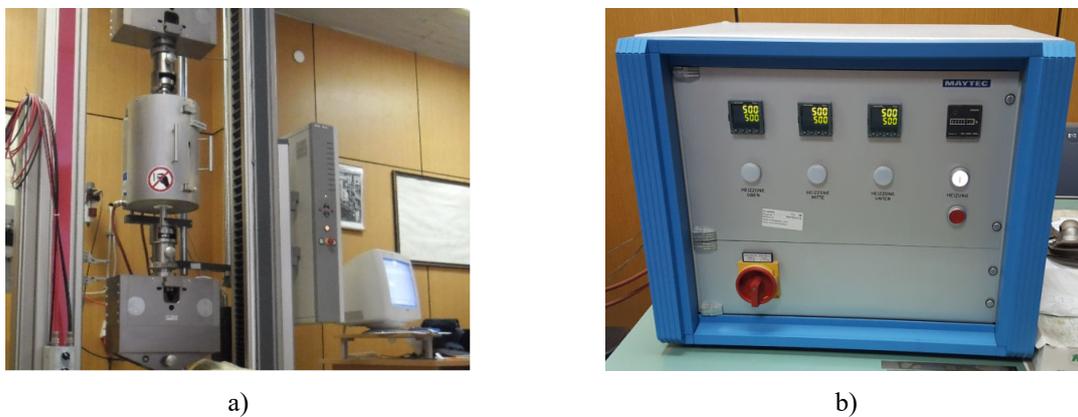
Fig. 3 Testing machine (a) and unit for control of testing temperature (b)

For heating the samples before and during the testing, a MAYTEC heating chamber and a control unit were used. Heating was done by electric spiral heaters positioned on the internal circumference of the chamber. Heaters are positioned along the whole length of the chamber. The temperature was measured by thermocouples positioned in three locations in the chamber – at the bottom, in the middle and on the top of the chamber. The specimens were heated for 30 minutes each to achieve the required temperature across the whole specimen.

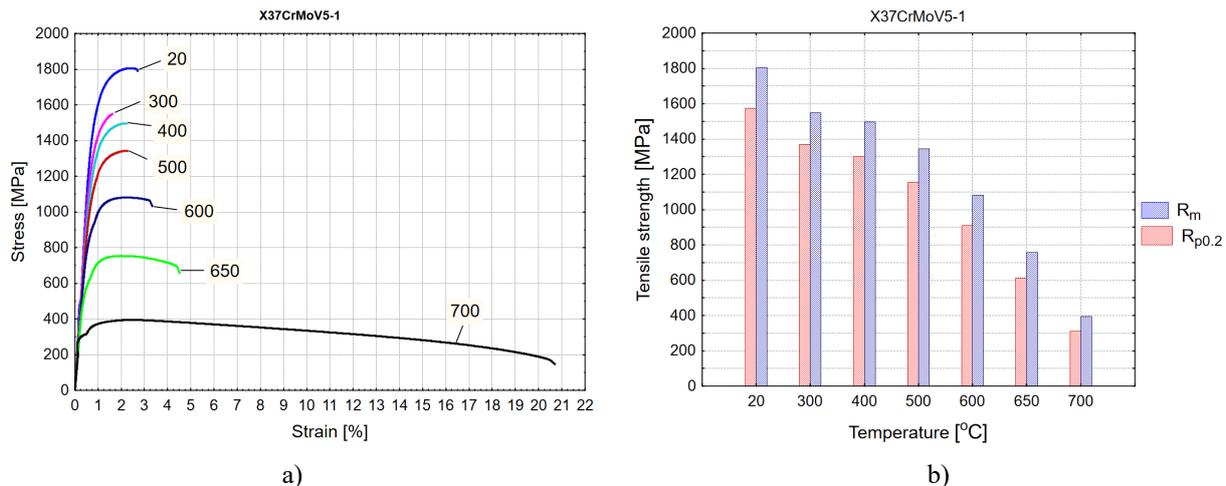
Fig. 4 Stress-strain diagram (a) and histograms of obtained properties at elevated temperatures (b)

The obtained experimental results are shown in Table 3 and in Figure 4.

The testing of the H11 tool steel showed that a significant decrease in tensile strength occurs at the temperatures higher than 650 °C (Figure 4). In fact, the results show a quick reduction in the ultimate tensile strength as soon as 600 °C is exceeded, but the full collapse occurs at 650 °C and above. A similar tendency was discovered in the previous study on the influence of high temperatures on tensile strength of the structural steel S690QL [23], where it was concluded that a decrease in tensile properties occurs at 450 °C. The tensile strength decrease with a temperature increase is expected due to recrystallization and softening. Microstructure softening is a combined action of temperature and stress. In true service conditions, the material is submitted to the two effects, each of them showing a cyclic evolution. Creep and stress-rupture tests, which combine the consequences of temperature and stress, are the first step to roughly classify materials, even if the cyclic parameter is not present; time to rupture in a simple stress-rupture test may be approximately linked to creep deformation speed. Creep, and consequently stress relaxation, when the heated surface of the tool is closely maintained in contact with the material to be transformed, is not significant for 5% chromium steels for temperatures below 500 °C but must be taken into account for temperatures above that. Figures 6a and 6b show that the stress-rupture resistance of the tested steel is much better at 500-550 than at 600 °C [6]. With a further temperature increase this decrease is more evident.

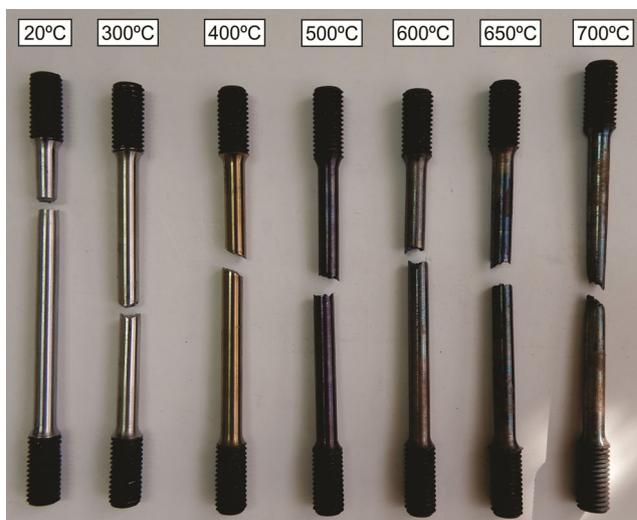
Fig. 5 Failure modes of H11 steel specimens at elevated temperatures

In addition, the effective stress and effective plastic strain are shown in Figs 8-14 for the moment before the fracture of the specimen occurs, at all testing temperatures. By analysing the deformed models tested at different temperatures one can notice that necking is visible at the temperatures greater than 600 °C, which is very similar to the real deformation that occurred on the experimentally tested specimens (Fig. 5).

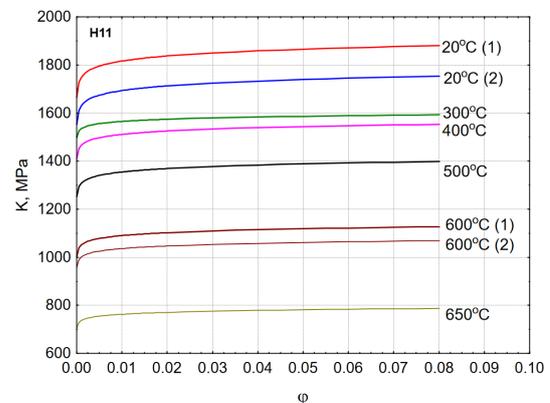
Fig. 6 Strain hardening curves for each testing temperature

The hardening curve was calculated for a single specimen at each testing temperature and the obtained results are shown in Table 4 and Figure 6. That data was then used for the FE analysis. The curve that would be related to the temperature of 700 °C is not given due to the high deformation over 25 %.

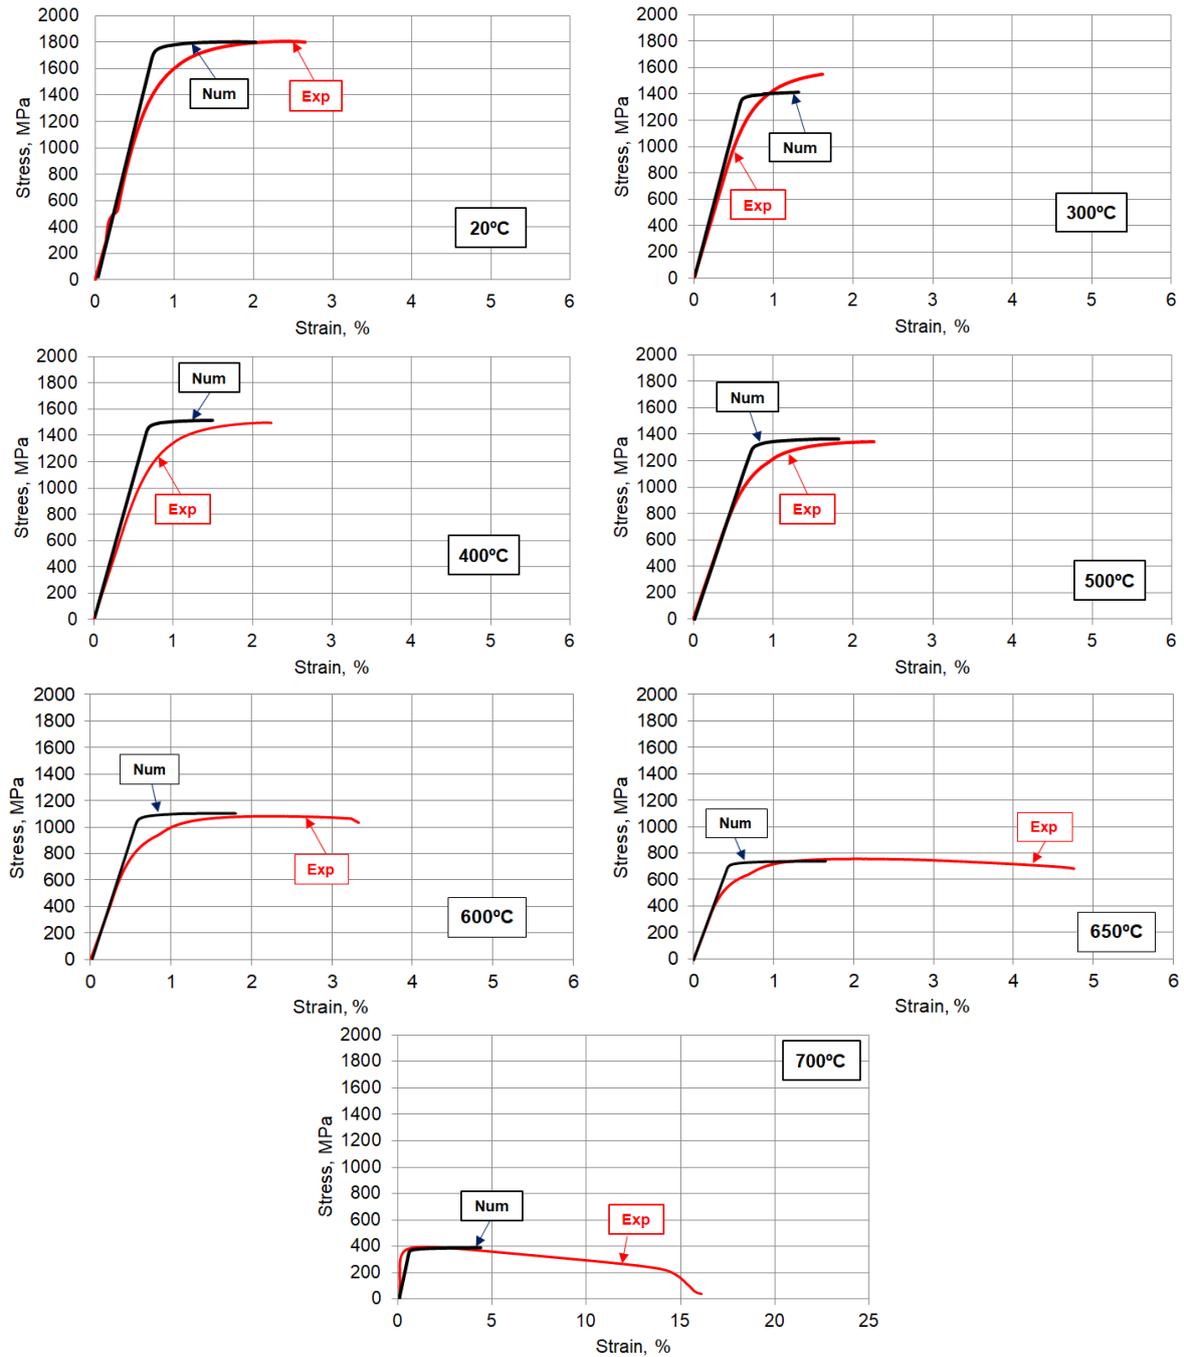
Fig. 7 Diagrams of experimental and numerical tensile testing in temperature range from 20 to 700°C

The obtained results for stress and logarithmic strain are compared with the experimental results. Figure 7 shows comparative diagrams within the temperature range from 20 to 700 °C. The obtained numerical results compared to the experimental results indicate that the deviation in stress is small but the deviation in strain is relatively large and not uniform, being the largest at 500 °C. One can consider restrictions of the model used in the numerical analysis to be the cause for these deviations since the model did not take all the variables in the tension process into account. The restriction of this model is also that the Ramberg-Osgood relationship can give results valid only up to the ultimate strength [27, 28], while strength hardening occurs, so there are no results for the zone after the ultimate strength is reached. Some further research should consider the use of more complex mathematical models such as the models shown in [29-31], which refer to the micromechanical analysis.

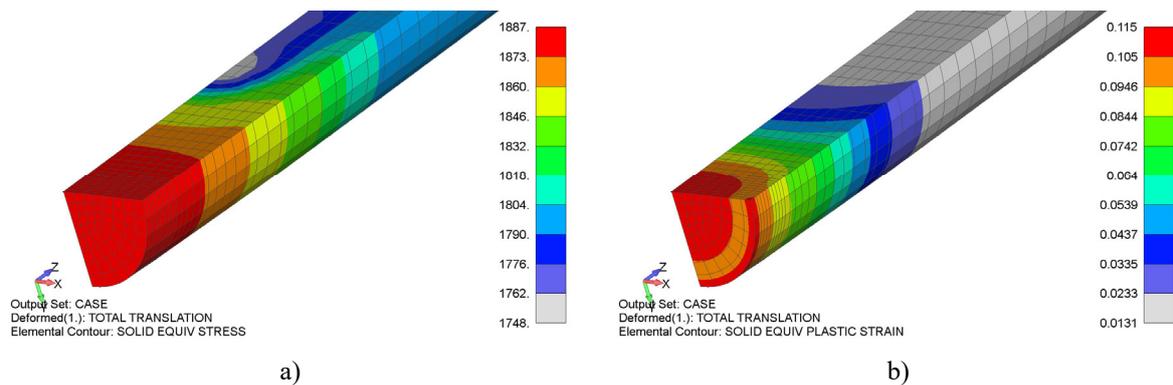
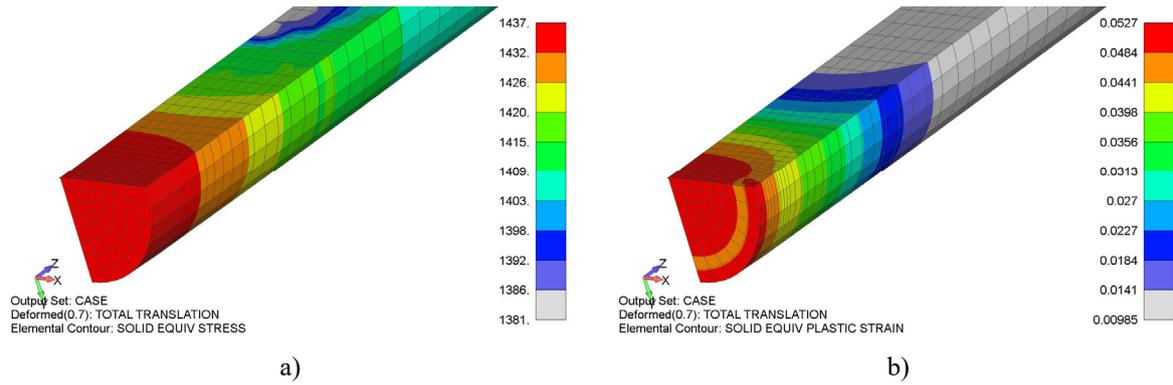
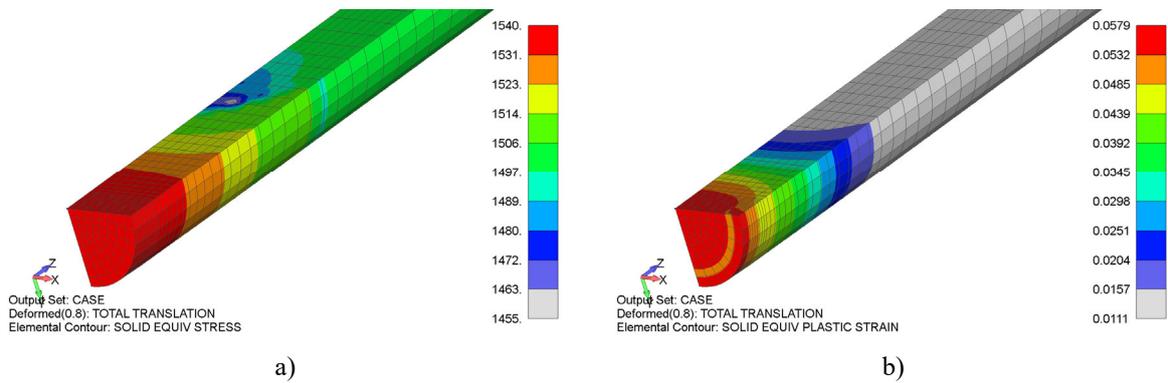
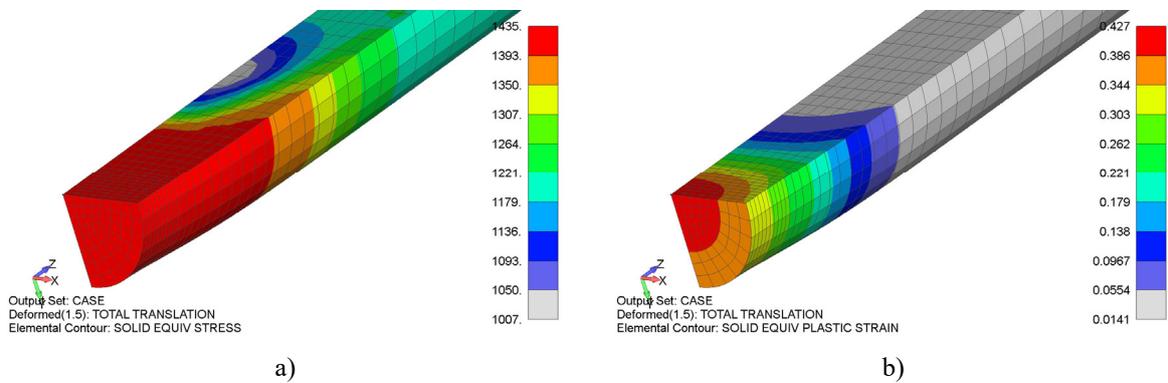
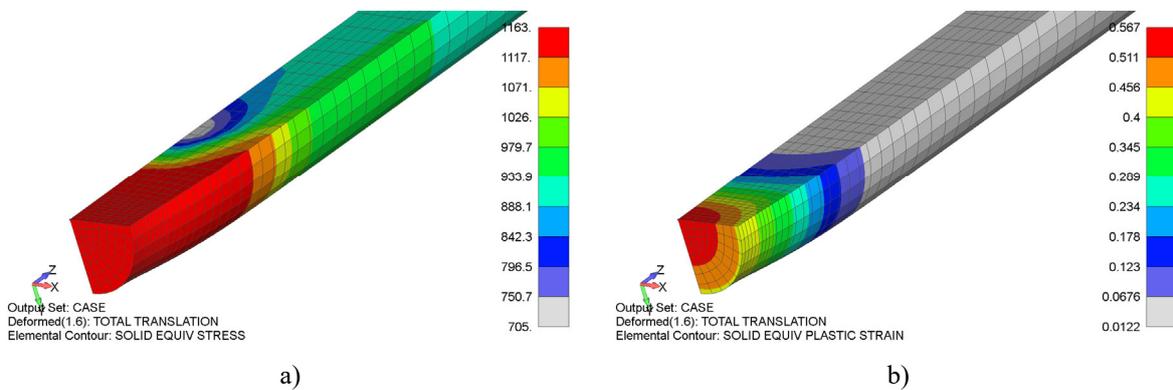
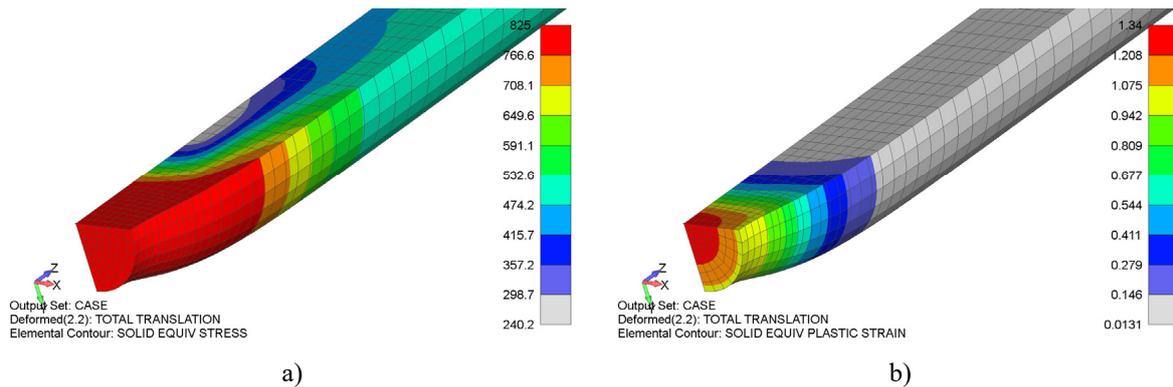
Fig. 8 Effective stress (a) and effective plastic strain (b) at the moment before fracture at 20 °C

Fig. 9 Effective stress (a) and effective plastic strain (b) at the moment before fracture at 300 °C

Fig. 10 Effective stress (a) and effective plastic strain (b) at the moment before fracture at 400 °C

Fig. 11 Effective stress (a) and effective plastic strain (b) at the moment before fracture at 500 °C

Fig. 12 Effective stress (a) and effective plastic strain (b) at the moment before fracture at 600 °C

Fig. 13 Effective stress (a) and effective plastic strain (b) at the moment before fracture at 650 °C

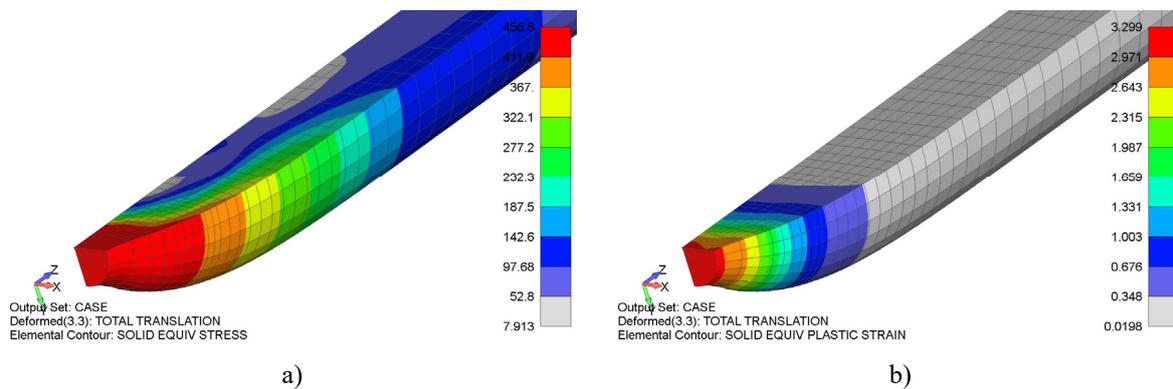
Fig. 14 Effective stress (a) and effective plastic strain (b) at the moment before fracture at 700 °C
