# Analysis of the Welding Type and Filler Metal Influence on Performance of a Regenerated Gear

Abstract: This paper presents the results of voluminous experimental investigations conducted to analyze the influence of the welding procedure on the performance of regenerated gears. Cylindrical spur gears were tested, both newly manufactured and regenerated, in two fundamentally different ways: by hard facing (surfacing) with the "hard" filler metal (DUR 600-IG) and with the "soft" filler metal (EVB2CrMo) with subsequent cementation and quenching. The regeneration procedures were defined and executed, while, subsequently, the microstructure and microhardness of the hard-faced layers were established and measured, followed by checking the durability of the hard-faced teeth flanks. Finally, techno-economic analysis was performed to establish the rationality of the conducted regenerations, i.e., the costs of regenerated and newly manufactured teeth were compared. Based on the results of the conducted investigations, it was possible to establish the influence of the welding type on the performance characteristics (primarily the service life) of the regenerated gears. For individual repara

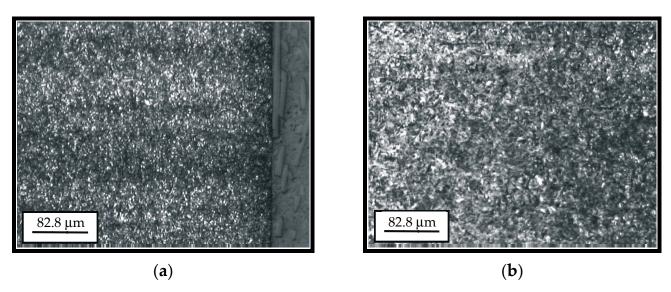
Figure 1. Microstructure of the cemented layer (a) and the transient zone (b).

The microstructure of the surface and subsurface layers (cemented layer and the core of the newly manufactured tooth) is presented in Figure 1a. The basic micro-constituent of the tooth cemented layer is the tempered martensite (dark areas in the figure). The smaller share of the retained austenite can also be noticed. In the surface zone, up to the depth of 0.2 to 0.3 mm, individual coarser carbides of the alloying elements are also present. Based on the appearance of the martensite needles, one can conclude that the material possesses a fine-grained structure, which points to the fact that the heat treatment process was properly conducted. Based on Figure 1b, one can see the difference between the microstructures of the cemented layer (the right-hand portion of the figure), microstructure of the transient zone (the middle portion of the figure) and microstructure of the core (the left-hand portion of the figure). Individual ferrite grains can be noticed in the transient zone (the coarser brighter areas), the number of which is much bigger in the core.

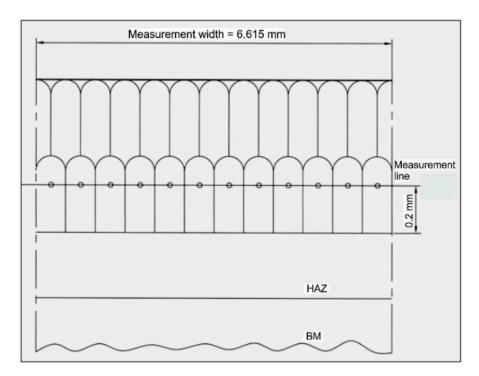
Figure 4. The measurement line of the dendritic crystals' medium width.

Since the exploitation characteristics of the hard-faced layer depend, to a great extent, on the size of dendrites within it, the dendritic crystals' width was measured on the optical microscope [26]. Those measurements were performed at a distance of 0.2 mm from the joint line, as shown in Figure 4. A total of 217 dendritic crystals were measured over the

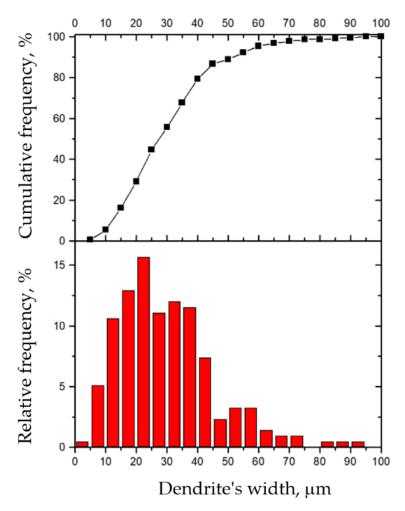
**Figure 5.** Cumulative and relative frequencies of dendrites' widths in the hard-faced layer deposited by the DUR 600-IG filler metal.

Based on the results presented in Table 2 and the diagrams in Figure 5, one can see that the average width of the dendritic crystals is 30.48  $\mu m$ . From the histograms, one can also notice that about 30% of dendrites have an average width of up to 20  $\mu m$ . About 45% of dendrites have an average width of up to 30  $\mu m$ , while about 80% have an average width of up to 40  $\mu m$ . A width of over 60  $\mu m$  is only achieved in about 3% of dendrites. The largest number of dendrites, i.e., 15.66% of them, have a width of 20 to 25  $\mu m$ , while 73.7% of dendrites have a width within the range of 10 to 40  $\mu m$ . Considering these results, one can conclude that the liquid bath during the hard facing had a relatively small volume and that the hard-faced layer possesses a fine-grained dendritic structure [26].

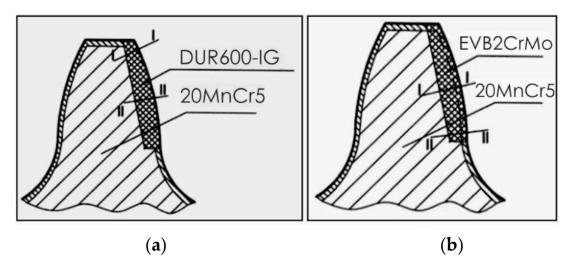
Figure 6. Microhardness measurements' directions: tooth hard-faced with the DUR 600-IG FM (a) and tooth hard-faced with the EVB2CrMo FM (b).

The microhardness of the teeth, hard-faced by the TIG procedure with the filler metal DUR 600-IG, was measured in two directions, close to the top of the tooth and in the zone of the pitch circle, Figure 6a. Results are presented in Tables 3 and 4, as well as in diagrams in Figure 7 [18]. For the tooth hard-faced with the filler metal EVB2CrMo, hardness was also measured in two directions, but in the zones of the pitch circle and the lowest area of the hard-faced layer, Figure 6b. Measurement results are presented in Tables 5 and 6, as well as in Figure 8.

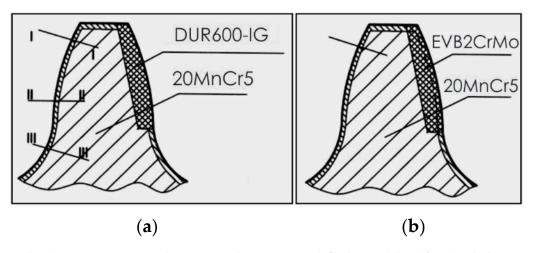
**Figure 9.** Microhardness measurements' directions on the inactive tooth flanks: tooth hard-faced with the DUR 600-IG FM (a) and tooth hard-faced with the EVB2CrMo FM (b).

Besides the conducted investigations, the microhardness of the inactive tooth flanks of the regenerated teeth was measured, as well. For the sample hard-faced with the DUR 600-IG filler metal, hardness was measured in three directions, close to the tooth top (I-I), in the pitch circle zone (II-II) and at the tooth base (III-III), Figure 9a, while for the tooth hard-faced with the EVB2CrMo filler metal, hardness was measured only in the middle of the tooth, Figure 9b. Measurements' results are presented in Tables 7–10, as well as in Figure 10.

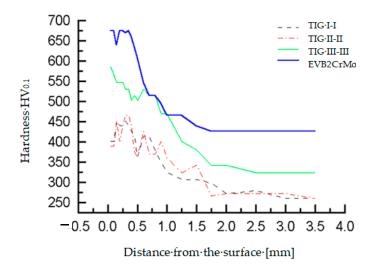
**Figure 10.** Microhardness measurement results on the inactive tooth flanks for the teeth hard-faced with FM DUR 600-IG and EVB2CrMo.

From the diagram in Figure 10, it is obvious that a hardness reduction occurs on the non-hard-faced surfaces of the teeth. From the presented results, one can easily notice that the largest hardness reduction occurs for the tooth hard-faced by the TIG procedure with the DUR 600-IG filler metal at the tooth head, while the tooth base (where there is much more material and which is further from the heat source during the hard facing) had the lowest hardness reduction. Such results were expected and are quite logical [26].

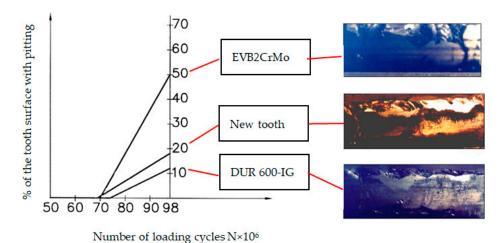
Figure 12. Destructive pitting development rate.

The appearance of the destructive wear, namely, the first pitting pits, was noticed after  $69 \times 10^6$  loading cycles for the newly manufactured teeth and for the teeth hard-faced with the EVB2CrMo filler metal after  $70 \times 10^6$  cycles. The longest operation prior to the appearance of the first pits was exhibited by teeth hard-faced by the TIG procedure and the DUR 600-IG filler metal, where the destructive pitting started after  $74 \times 10^6$  loading cycles. After  $98 \times 10^6$  loading cycles, the full duration of tests, for newly manufactured teeth, 18% of the most endangered tooth surface was covered with pitting; for the tooth hard-faced with the EVB2CrMo filler metal, the attacked area was about 50%; and for the tooth hard-faced by the TIG procedure, this was only about 12%. Analyzing the operation time until the first appearance of the destructive pitting of the regenerated and newly manufactured teeth produced the diagram shown in Figure 12.
