## **RELIABILITY ANALYSIS OF BALL BEARING ON THE CRANKSHAFT OF PISTON COMPRESSORS**

Technically the system that is the subject of research in this paper is a reciprocating compressor. The goal of the research presented in this paper was to examine the reliability of operation reciprocating compressor with a single cylinder. This study is based on monitoring diagnostic parameters of axial clearance and temperature on tested ball bearings, which are located on the crankshaft of the compressor. The reliability in the work was analyzed observed through monitoring of axial clearance and the temperature of ball bearings and was performed in the laboratory conditions testing. Results of the research on the tested ball bearings show that the size of the axial clearance correspond to the sizes and the temperature before the period of notice that condition and are a good indicator of the reliability of the technical system.

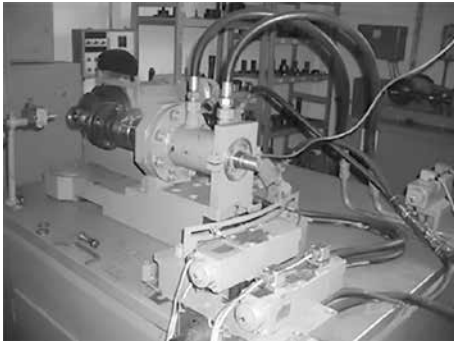
**Fig. 3.** Laboratory tables for dynamic testing the bearings

Exploitation tests of reliability bearing would require many years (~12 years), for this reason the laboratory test method is selected how would shorten the test time. For the purposes of the dynamic tests of ball bearing on the compressor was used is an experimental laboratory table (Fig. 3) – FAD AD Gornji Milanovac, which is intended for dynamic testing of the reliability of the bearing the same is suitable for testing the joint dowels in vehicles.

test sample transferred via a hydraulic cylinder, a measurement of stiffness (clearance) is accomplished over force transducer with by strain gauges (10) and with inductive displacement transducer (I). The base devices (welded construction – 6) carries the lower bearing plate with superstructure. The upgrade of the pillars (12) and the stationary beams which the bearing plate provides in a closed frame. On the lower beam appointed is a force transducer with upper part the tools for examination (9). Displacement transducer is placed in a moving the carrier thus that it can be set on any place on the board and finely tune the height by using the scroll wheel. On the bottom side of the carrier plate, in the middle part, is set the

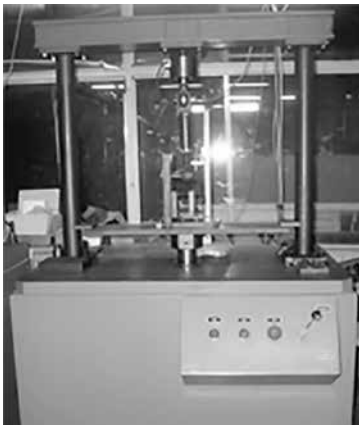
**Fig. 4a.** Appearance laboratory of the table

is also suitable for testing bearings loaded alternating variable load, the angular oscillation and the angular rotation whereby the parameters vary according to the particular frequency. At the termination of individual phases at specific time moments testing samples are still taken to a laboratory for testing on table the clearance, Fig. 4a.

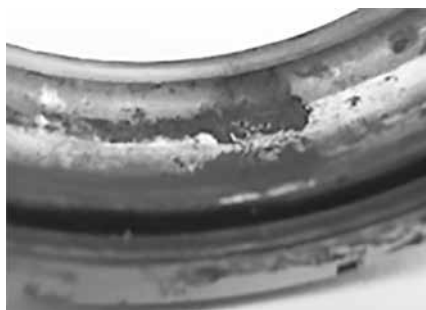
**Fig. 10.** Fretting corrosion on the outside of the track ball bearing

oxidizing environments and without the development of chemical reactions materials contact surfaces and products wear with oxygen. In Fig. 10 it is shown in the case of fretting corrosion at the outer track ball bearing.
