# Geological and Geotechnical Aspects of the Most Significant Deep Landslides in the Danube Area on the Territory of Vojvodina

**Abstract:** The largest and the deepest landslides in Serbia occurred on the right valley side of the Danube. General conclusions about landslides along the Danube were obtained on the basis of their comprehensive, detailed investigations: the Sloboda bridge in Novi Sad, the Beška bridge, the large settlement of Bocke, and the high-speed railway viaduct in Čortanovci. These areas are actually large, unstable slopes with deep and shallow landslides. Deep landslides consist of several sliding blocks with 20–40 m in depth. All these landslides were formed in clays and sands of the Pliocene age in the decayed crust of these sediments. The general conclusions about landslides presented in this paper will be of great use for the construction of new facilities in the entire unstable area along the Danube, which is about 100 km in length.

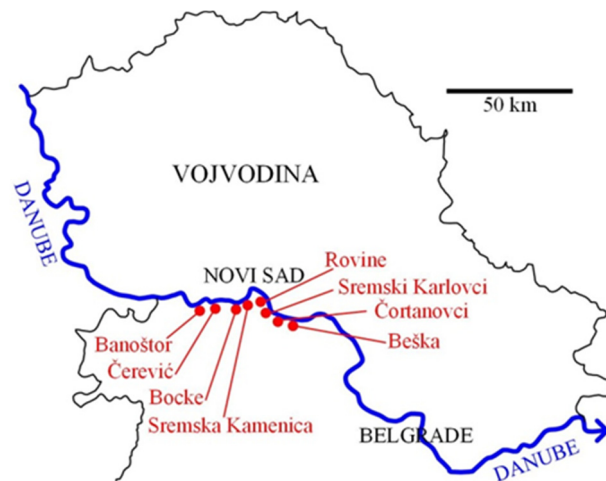
**Figure 1.** Locations of unstable slopes along the Danube.

paper points out the fact that these are unstable slopes extending several kilometers in length along the Danube area. These unstable slopes consist of a great number of smaller but deep landslides. Their displacements vary in time as well as in amount and direction [11]. Figure 1 shows the locations of the largest unstable slopes along the Danube in Vojvodina.

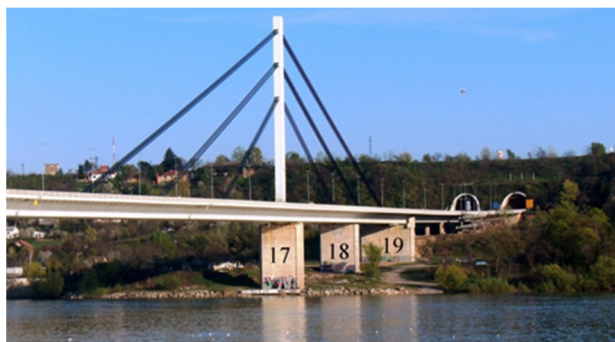
**Figure 3.** Landslide in the area of the Sloboda bridge in Novi Sad, with piers 17, 18, and 19 of the bridge.

This paper highlights only some results of detailed studies where significant objects were endangered by the landslides: the Sloboda bridge in Novi Sad (Figure 3), the Čortanovci viaduct on the Belgrade–Budapest high-speed railway, and the Beška bridge on the Belgrade–Subotica highway.

The Sloboda bridge is located on an unstable slope in Sremska Kamenica. Its structure (Figure 3) is sensitive even to small slide displacements. Therefore, very thorough investigations of landslides in that area have been conducted over a long period of time. The main project of the correctional works will be performed in three phases. Phase I-a is the construction of drainage wells DW-1 and DW-2, with four drains stemming from both of them. The drains connecting the pressure chambers and the wells are positioned in the Pliocene sand. Phase I-b is the insertion of drains from the surface terrain into the sandy gravel sediments (the so-called Srem series) that are found below the loess layer. Phase II

of the stabilization process is the construction of the bank revetment and the re-grading of the slope. Phase III is the construction of six supporting structures made from concrete box diaphragms acting as counterforts built into the lower level of the slope.

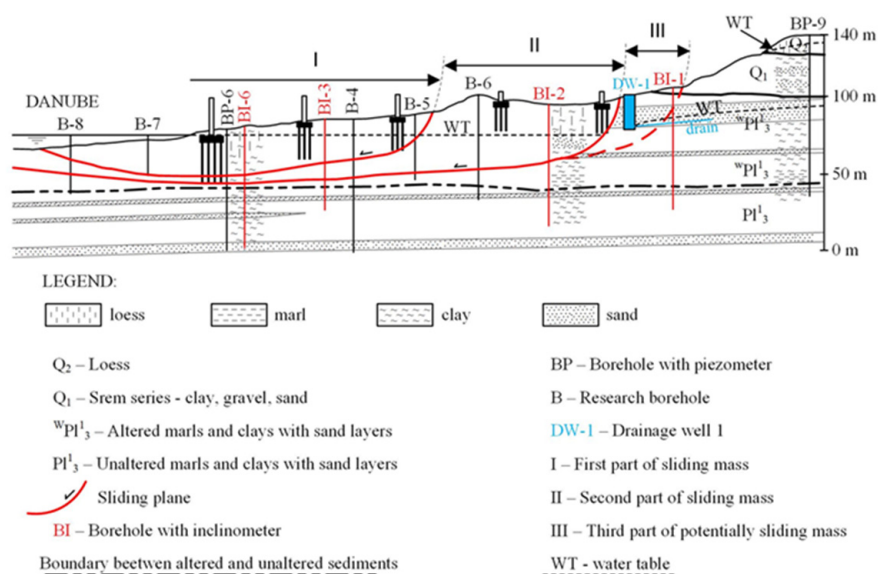
**Figure 4.** Geological and geotechnical cross-section of the study area.

The composition of the soil and the main sliding plane (Figure 4) in the area of the Sloboda bridge were determined. Large landslide displacements, which endanger the pile-founded bridge structure, take place in two blocks with the possibility of expanding the sliding process to the third block. The terrain was drained using two deep wells from the layer of sand that was in the BI-1 drill zone. The completed drainage wells DW-1 and DW-2 are 22 m deep and have internal diameters of 6.50 m and concrete walls 0.45 m thick. Four drains 45 m long lead from each of the wells. Such drainage is the first repair measure.

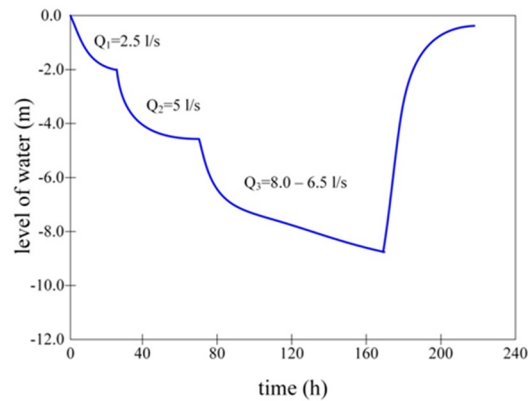
Figure 5. Test drainage in DW-1.

A drainage test was carried out after the construction of the wells and all the drains leading from them. Tests were performed by measuring the inflow from each of the drains both individually and together. During the test, levels of groundwater were measured using all of the installed piezometers. After the water level within the well stabilized due to the inflow of water from all the drains, test drainage was performed by pumping water from the well. Simultaneously, the levels of groundwater were measured using piezometers. The testing lasted approximately a month for each of the wells. Figure 5 shows the water level reduction in the DW-1 in three stages of the test drainage and the water level restoration in the well after the drainage ended.

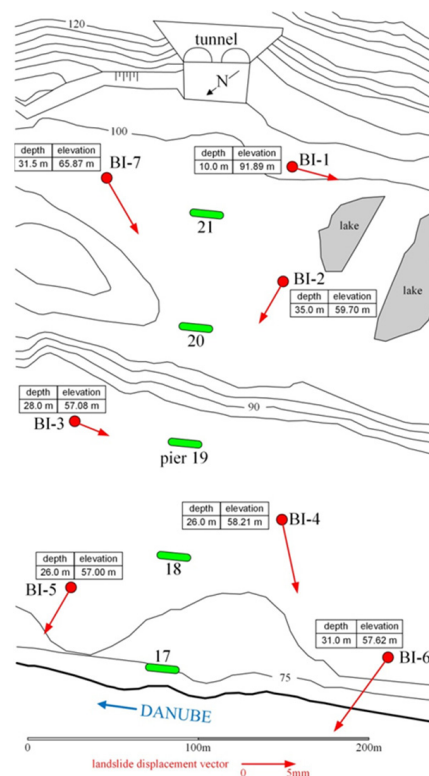
Figure 6. Landslide displacement vectors.

Multi-year measurements have been performed on seven inclinometers in the Sloboda bridge area. For each inclinometer, the average intensities of displacement vectors over one year are shown (Figure 6). The displacement vectors show that some landslides move upstream, others downstream, and some toward the Danube. The displacement mechanism probably operates by a pattern according to which a displacement of the first deep landslide along the Danube would probably lead to a displacement of the next landslide on the slope. Figure 6 shows pillars 17, 18, 19, 20, and 21 of the bridge, which are on the landslides and also on the places of the inclinometers. The data on the depth and elevation of the deepest sliding plane are shown.

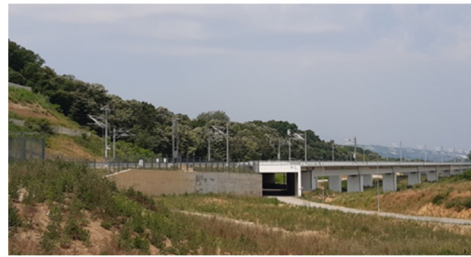
**Figure 7.** Viaduct on the Čortanovci landslide zone of the Sloboda bridge.

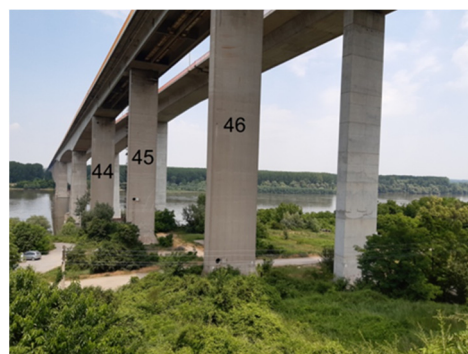
**Figure 8.** Bridge on the Beška landslide.

A large bridge on the Danube was built in the landslide zone of Beška. Despite the fact that the bridge was known to lie on a landslide (Figure 8), after its completion, serious problems arose, and the bridge had to be repaired immediately. The main recovery measures consisted of the production of deep piles. Part of the bridge near Beška, on the right bank of the Danube, has six pillars with 45 m to 60 m distance between them. Figure 9 shows only pillar site 45, lithological soil types in the zone of that pillar, originally constructed piles, and additionally constructed deepened piles as parts of the remediation. The deepened piles are finished in marl blue clay, middle 4, which forms a stable part of the terrain. Deepened piles were also made for pillars 44 and 46 (Figure 8). For pillar 45, 10 drilled piles with a diameter of  $D = 0.90$  m were made, with the base of the piles at an elevation of 70.50 m. In addition to the fact that the rehabilitation envisaged and performed deepened the drilled piles to the required length, other rehabilitation measures were applied, such as drainage, making a stone bank revetment, relieving, and landscaping in the bridge area.

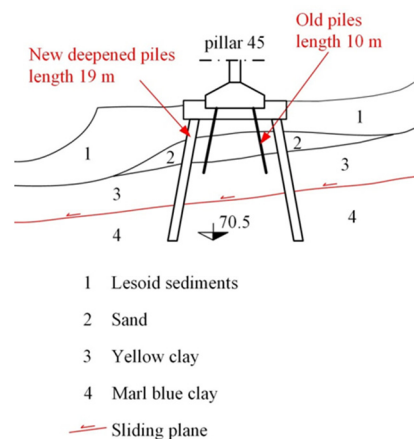
**Figure 9.** Pillar 45 with subsequently drilled piles.
