# Investigation of Tensile Properties at Room and Elevated Temperatures of S1100QL Steel and Its Welded Joints

**Abstract:** The aim of this paper was to present an experimental study into the influence of elevated temperatures on the tensile properties of the ultra-high-strength steel (UHSS) S1100QL and its welded joints. S1100QL steel belongs to the group of structural steels, and it is mainly used for designing various types of lifts and cranes with the goal of decreasing the mass of structures while increasing their load capacity. Since the structures mentioned are mostly produced as welded structures, tensile tests were also conducted on the specimens prepared from two different types of welded butt joints made of S1100QL steel. One plate was welded with a preheating temperature of approx. 175 °C with a similar undermatching filler material, and the second plate was welded with slight preheating and with two different filler materials. For the root pass, an austenitic filler material was used, and for further passes the same undermatching filler material as in the first case was used. The goal of this study was to determine the highest temperature at which the steel and its w

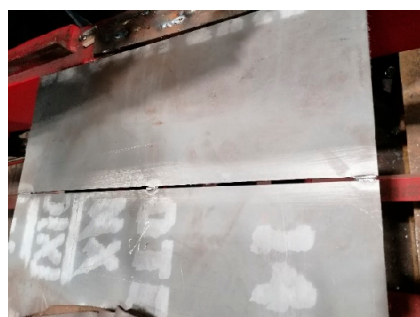
**Figure 3.** Display tack welded plates.

The prepared plates were joined manually with several tack welds (Figure 3) to form a groove for the weld metal to be deployed. For this technology, according to the steel producer, the root pass was welded using an austenitic stainless-steel filler material and without preheating. In this case, the G 18 8 Mn grade of filler material is recommended, and according to recommendations, the authors chose SI Jesenice's MIG 18/8/6 Si filler material (SI Jesenice, Jesenice and Slovenia), since it fulfills the posed conditions. The chemical composition and mechanical properties, as well as the recommended welding parameters, are displayed in Tables 5–7 [22].

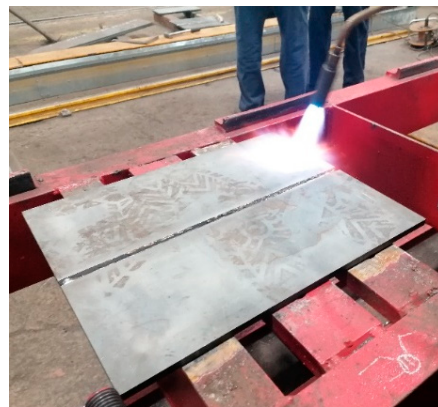
**Figure 4.** Plate preheating using LPG torch.

In this technology, preheating the prepared plates is not recommended due to the possible effect of temperature on the properties of the weld metal. According to extensive research experience in earlier work with similar steel grades, the authors chose to slightly preheat the prepared plates before welding the root pass, even though the producer does not recommend this. For this purpose, a liquid petroleum gas (LPG) torch was used to achieve a preheating temperature of 120 °C (Figure 4). The idea was to clean the groove and burn possible impurities found on the beveled edges. The preheating temperature was measured on the plates, 100 mm away from the groove. Heat input is defined by the steel producer, and it ranges from 8 to 12 kJ/cm.

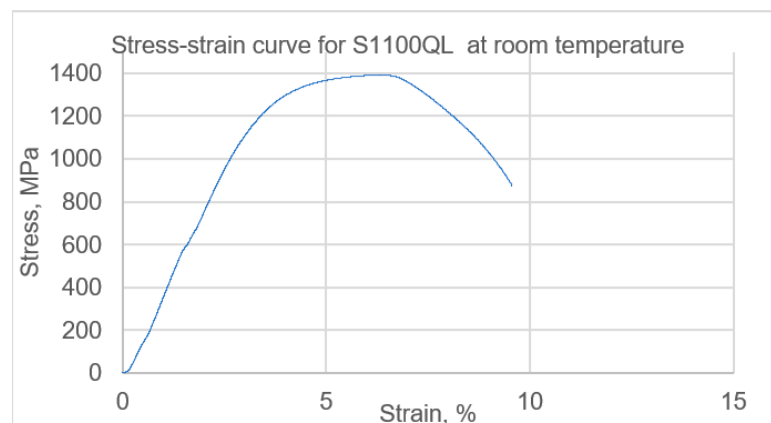
**Figure 11.** Stress–strain curve for S1100QL at room temperature.

The results of tensile testing of the base material at room temperature are displayed in Table 13 below. The yield stress and the ultimate tensile strength are within range of values stated by the steel producer. The elongation values are slightly lower than expected. The stress–strain curve for one of the specimens is displayed in Figure 11, and the broken specimen is displayed in Figure 12.

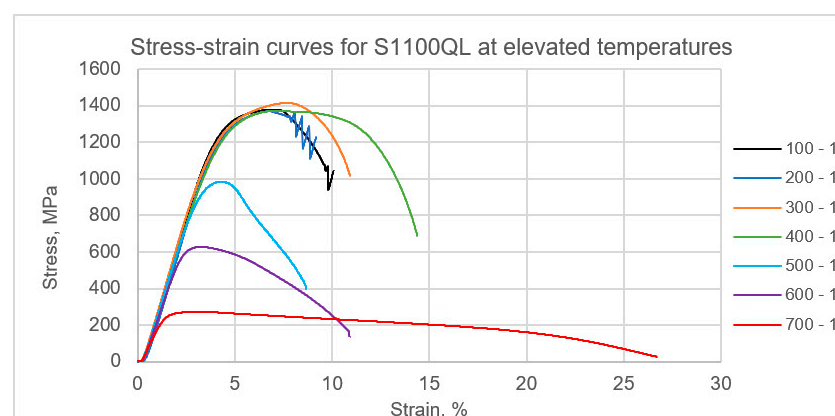
**Figure 13.** Stress–strain curves for base material at elevated temperatures.

The tensile test results for the base material at elevated temperatures are displayed in Table 14. The results obtained indicate that this steel retains its strength at up to 400 °C. At 500 °C, the strength drastically drops, and elongation begins to rise. This is due to the influence of temperature on the material's plasticity. Examples of the recorded stress–strain curves for all the temperatures tested are displayed in Figure 13. Observing Figure 13, one can notice a sudden drop in strength after 400 °C. Broken specimens are shown in Figure 14.

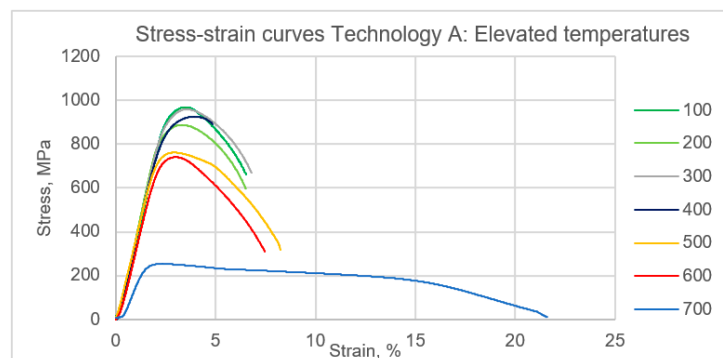
**Figure 17.** Stress–strain curves for technology A specimens at elevated temperatures.

The tensile tests results for welded specimens at elevated temperatures are displayed in Table 18, and the recorded stress–strain curves are displayed in Figure 17 below. From the results obtained and the showcased stress–strain curves, it can be noticed that with increasing temperature the strength moderately drops. At temperatures up to 400 °C, the strength is lower than at room temperature, but it is not dropping. At 500 °C and 600 °C, the strength is slightly degrading, while elongation rises. Finally, at 700 °C, the strength drops drastically, and the elongation values exceed 20%. Display of broken specimens is given on the Figure 18.

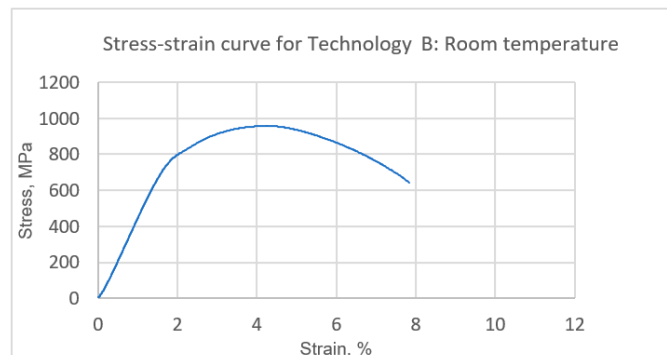
**Figure 19.** Stress–strain curve for technology B at room temperature.

The tensile test results obtained show that at room temperature the yield stress and ultimate tensile strength are slightly lower compared with the results obtained for Technology A's welded joint. Elongation values are also lower than the results obtained with technology A. The results are displayed in Table 21, and one example of a stress–strain curve is displayed in Figure 19, and a broken specimen is shown in Figure 20.

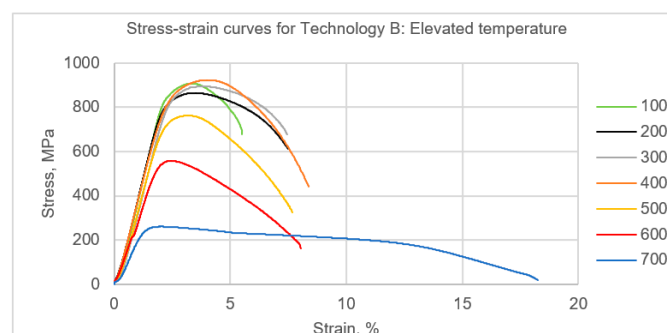
**Figure 21.** Stress–strain curves for specimens from technology B at elevated temperatures.

The results displayed (Table 22) show that the yield stress and ultimate tensile strength values are similar up to 400 °C. At temperatures higher than that, the strength begins to slowly degrade, which confirms the results of tests at 500 °C, 600 °C, and 700 °C. As the test temperature increases, elongation values rise as well, reaching their maximum values at 700 °C (Figure 21). The specimens after experimental testing are displayed in Figure 22.

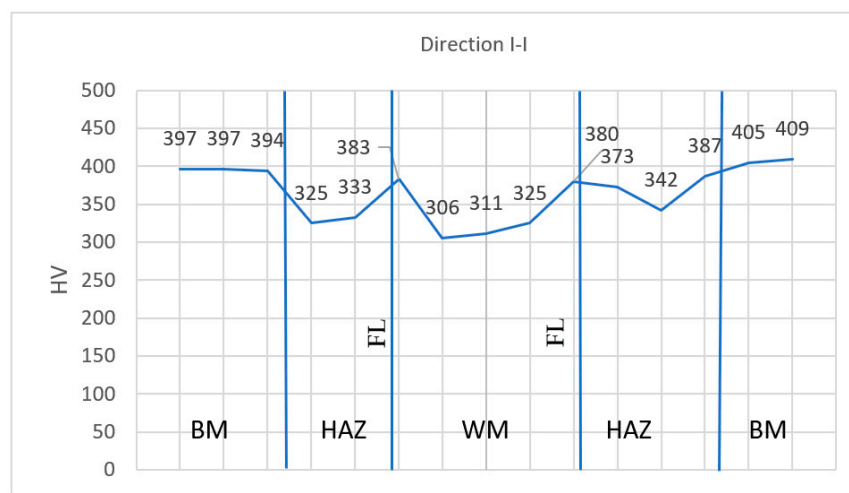
**Figure 31.** Hardness distribution throughout direction I-I on the technology B welded joint.

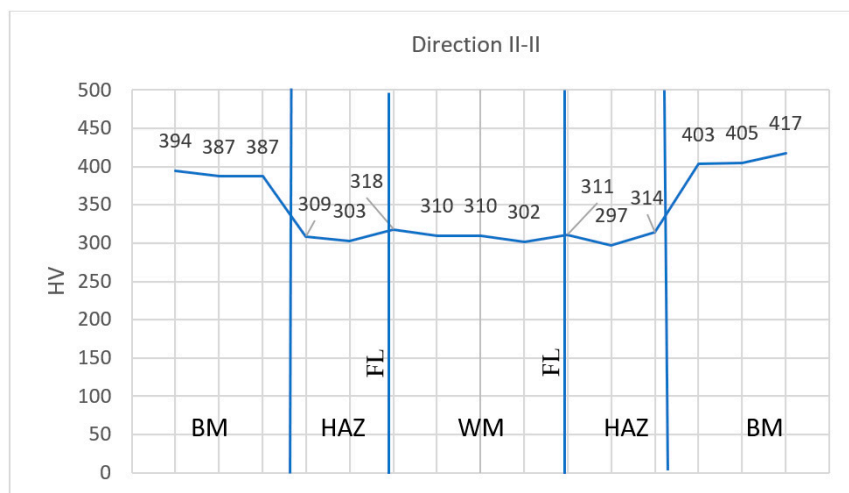
**Figure 32.** Hardness distribution throughout direction II-II on the Technology B welded joint.
