ANALYSIS OF BRAKE DRUM DAMAGE IN MOTOR VEHICLE BRAKING SYSTEMS

*Dobrivoje Ćatić¹, Faculty of engineering, University of Kragujevac
Vladimir Ćatić², HTEC Group*

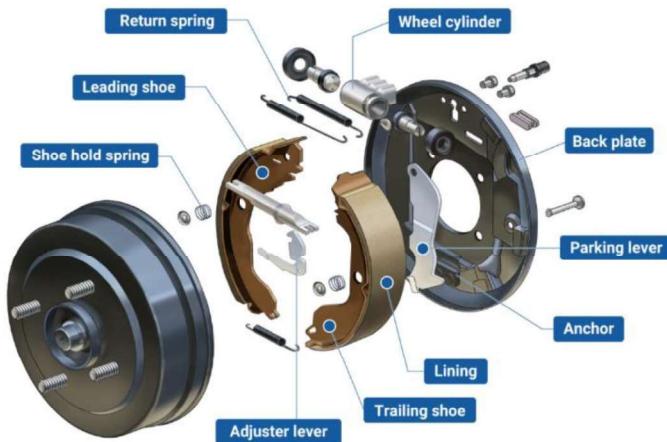
Figure 1. Components of the drum brake mechanism

The brake drum shown in Figure 1 [4] represents a single-acting brake, the so-called simplex brake. The considered drum brake model operates as follows. By pressing the brake pedal, the brake fluid under high pressure from the master cylinder is delivered through metal and flexible pipes to the wheel cylinders. The high oil pressure actuates the pistons of the wheel cylinder, which act on the upper ends of the brake shoes, pressing the friction lining against the surface of the drum. The radial pressure of the shoe linings on the drum surface generates friction, which slows down the rotation of the drum and, consequently, the vehicle wheel. When braking ceases, the drum brake components return to their initial position, allowing the drum to rotate freely.

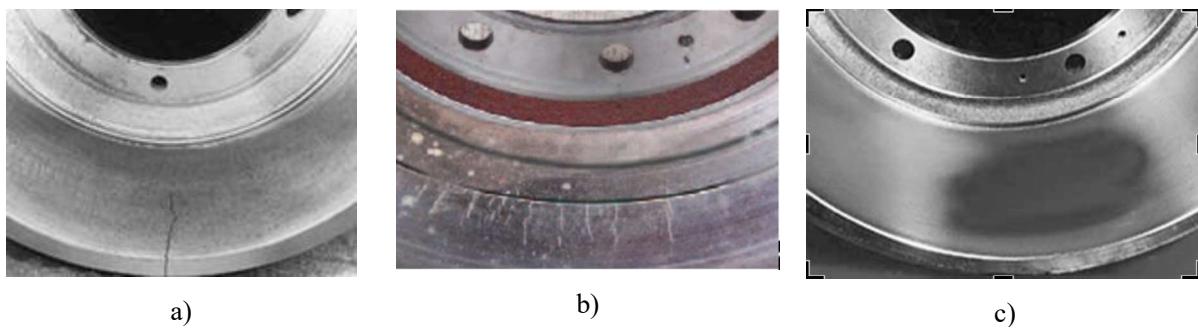
Figure 2. a) Cracked drum, b) Heat-checking, c) Oiling/greasing of friction surfaces
Source: [5,6]

During service, the brake drum and shoe linings are subjected to friction and wear under high thermal loads. Consequently, various forms of damage may occur, leading to a reduction in the overall performance of the braking system [5, 6, 7]. Cracked drums (Figure 2. a)) [5] are typically detected by visual inspection. The crack in the drum has an axial orientation and extends through the entire drum wall. The most common cause of drum cracking is excessive heating and cooling during operation. In addition, cracks may occur if the drum is not suitable for a particular application or in

cases of driver misuse during braking (extreme braking conditions). Reduction of drum wall thickness due to wear, or due to machining aimed at eliminating observed defects, decreases the static strength of the drum and increases the likelihood of crack initiation. In the region of the drum affected by a crack, elastic deformations are more pronounced, leading to uneven pressure distribution along the arc length of the brake lining and a significant reduction in braking torque. As a result, brake vibration becomes highly pronounced. A cracked drum must be replaced, which means that this failure mode results in a complete brake drum failure.

Heat-checking (Thermal cracks) (Figure 2. b)) [6] appears as a series of narrow, short, and shallow cracks on the braking surface of the drum. They occur under normal operating conditions as a result of alternating heating and cooling of the drum's friction surface and represent a typical characteristic of drum brakes. Heat checks do not affect the braking torque of the drum brake. Due to their shallow depth, thermal cracks tend to disappear with wear of the friction surface and reappear as a normal outcome of the braking process. However, there is a possibility that heat checks may gradually develop into more severe cracks, in which case drum replacement will be required. For this reason, during routine inspections of the vehicle braking system, attention should also be paid to the condition of thermal cracks in the drum.

Oiling/greasing of friction surfaces (Figure 2. c)) [5] occurs when the drum and shoe friction surfaces become contaminated with oil or grease, either from the external environment, from brake fluid leakage in the wheel cylinder, or from grease leakage in the wheel hub due to poor sealing. Such contamination leads to a drastic reduction in the coefficient of friction and braking efficiency. If the interior of the drum brake has been exposed to contamination over an extended period, oil or grease may penetrate the drum material, causing discoloration of the braking surface. Restoration of braking performance requires eliminating the source of oil or grease, thoroughly cleaning all drum brake components, and grinding the friction surfaces. If the brake shoe linings are soaked with oil or grease, they must be replaced.

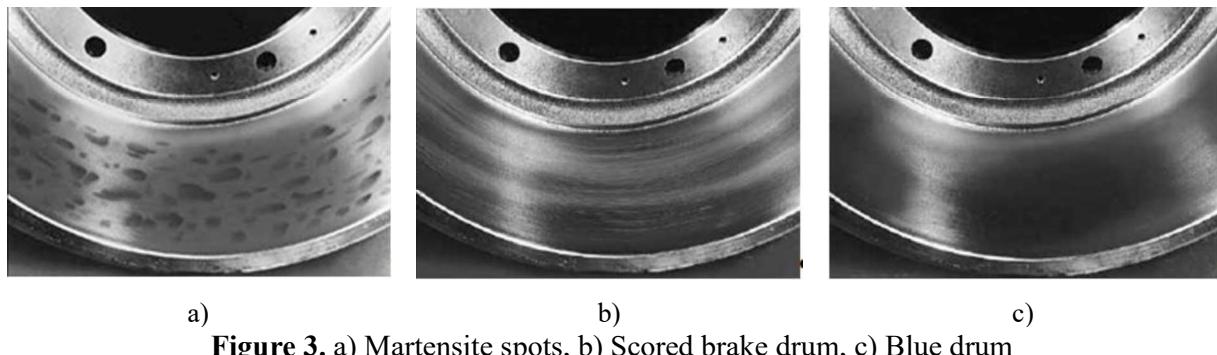
Figure 3. a) Martensite spots, b) Scored brake drum, c) Blue drum

Martensite spots (Figure 3. a)) [5] appear as extremely hard, slightly raised dark spots on the braking surface of the drum. The presence of such spots indicates that the drum has been exposed to operating regimes that caused structural changes in the drum material. During rapid cooling of a heated grey cast iron drum, the austenitic structure of the material transforms into martensite. This transformation is accompanied by a relative volume increase of the material, leading to the formation of raised dark spots on the drum's friction surface. The existence of these hard, elevated spots results in reduced braking torque, severe localized heating that can cause drum deformation and the initiation of surface cracks, uneven wear of brake linings, as well as vibrations and excessive noise during braking. Failure to detect martensite spots in time and to eliminate the causes of drum overheating inevitably requires drum replacement.

Scored brake drums (Figure 3. b)) [5] are characterized by pronounced deep grooves on the braking surface of the drum. Such grooves may occur due to completely worn-out brake linings, which cause direct contact between the drum and the metallic backing plate of the brake shoe, leading to severe wear. Similarly, when a friction lining cracks, fragments of the lining may become trapped

between the drum and the shoe, producing grooves. At elevated operating temperatures, the hardness of the drum's sliding surface decreases, making it susceptible to abrasive wear when in contact with hard inclusions from the brake linings. In all these cases, besides the reduction of the friction coefficient between the friction elements, braking efficiency decreases, noise during braking increases, and intense abrasive wear of the drum surface occurs in the form of deep grooves. If the grooves are not excessively deep, they may be removed by machining the drum, provided that the maximum permissible drum diameter is not exceeded. Otherwise, the drum must be replaced.

Blue drums (Figure 3. c)) [5] manifest as localized discoloration of the drum's friction surface. Incomplete contact between the friction surfaces of the drum and the brake linings leads to uneven heat distribution across the surface and the formation of thermal, or so-called blue, spots. The contact areas of the drum surface are subjected to higher heating. As a result, the structure of the drum material changes and its hardness increases significantly. If the causes of blue spot formation are not eliminated, continued operation of the drum may lead to the development of martensite spots, with all the associated consequences. The presence of blue spots in a limited extent does not require machining or drum replacement.

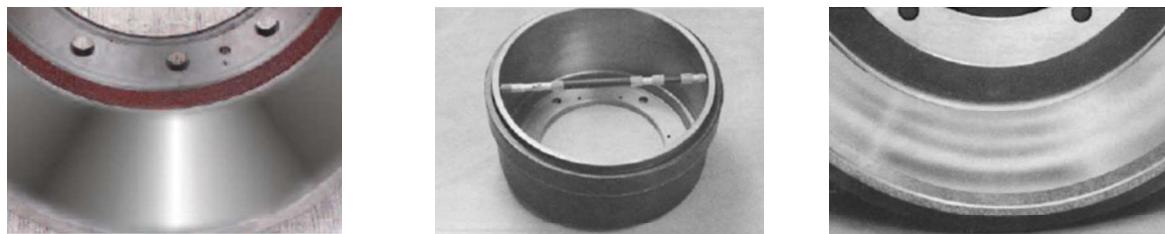
Figure 4. a) Polished drum, b) Drum deformation, c) Excessive wear

Polished drums (Figure 4. a)) [6] can be identified by a smooth, shiny braking surface. It has been observed that the problem of polished drums occurs much more frequently when asbestos-free brake linings are used. The presence of polished surfaces leads to a reduction in the coefficient of friction between the drum and the brake shoes. Once polished drum surfaces are detected, it is necessary to grind the drum and lining friction surfaces with sandpaper of appropriate grit size. In addition, when replacing brake linings, grinding of the drum's braking surface is recommended.

Out-of-round drums are indicated by variations in drum diameter at different points on the braking surface and by uneven wear of the drum and brake linings. Drum deformation occurs due to severe localized heating during braking and subsequent uneven cooling, which leads to the formation of thermal residual stresses that are superimposed on service stresses. Depending on the intensity of the total stress, plastic deformations may occur, manifested as a loss of concentricity of the drum's sliding surface and a transition from a circular to an oval shape. The extent of drum deformation is determined by measuring the diameter at different points on the braking surface (Figure 4. b)) [7]. If the maximum measured diameter of the drum's braking surface remains below the allowable service limit, the drum can be machined to restore concentricity. Otherwise, the drum must be replaced.

Excessive wear (Figure 4. c)) [7] of the drum along the edges of the contact surface between the lining and the drum may be caused by improper contact during braking due to incorrect installation or deformation of the drum or brake shoes. Wear of the drum in areas corresponding to the rivet holes of the lining occurs as a result of abrasive material accumulation in those regions. After detecting excessive wear, the first step is to identify and eliminate the cause. Subsequently, as with the presence of grooves on the drum's sliding surface, if the wear depth is within the allowable service limit, the drum can be machined to remove the damage. Otherwise, the drum must be replaced.

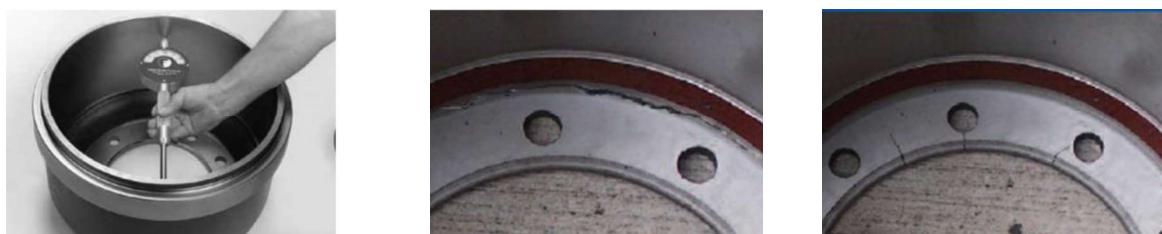
Figure 5. a) Oversized (worn) drum, b) Mounting ring cracking, c) Radial cracking of the bolt holes

Oversized (worn) drums. Over time, under normal operating conditions, friction causes wear of the drum and brake shoe lining surfaces. As wear progresses, the lining thickness decreases, the drum's inner diameter increases, and the wall thickness is reduced. An increase in the drum's inner diameter up to the service limit is the most common reason for removing a drum from service. In addition, the presence of grooves on the drum's sliding surface, uneven wear around the drum circumference, loss of concentricity due to plastic deformations, and similar issues often require machining to eliminate the observed defects. However, such machining further increases the drum's inner diameter. With reduced wall thickness, the drum's capacity to absorb and dissipate heat generated during braking is diminished. This leads to a significant rise in operating temperature of the drum brake, a reduction in the coefficient of friction, further diameter increase due to thermal expansion, deterioration of the drum material's mechanical properties, and other adverse effects. Each brake drum is stamped by the manufacturer with the nominal diameter of a new drum and the maximum allowable diameter, beyond which the drum must be replaced. Figure 5. a) [5] illustrates the procedure for measuring the inner diameter of a brake drum. Mounting ring cracking (Figure 5. b)) [6] can be identified by the presence of fractures or cracks along the circumference of the drum's mounting surface. This defect occurs when interference exists between the contact surfaces of the hub and the drum. The most common causes of cracks in the mounting ring are improper drum installation on the hub during assembly, hub damage, or the accumulation of dirt and corrosion on the hub surface. In addition, if an inappropriate drum is installed, with a smaller mounting ring diameter than the hub's supporting surface, mounting ring damage may occur. Radial cracking of the bolt holes on the mounting surface (Figure 5. c)) [6] occurs due to the same causes already described for mounting ring cracking. If any cracks are detected along the circumference of the drum's mounting surface or around the bolt holes, the drum must be replaced. Before installing a new, suitable drum, it is necessary to visually inspect the hub's supporting surface and eliminate any defects by cleaning the hub or replacing it if required. In addition, during drum installation, it must be ensured that the mounting surface of the drum fits properly and evenly onto the hub's contact surface. Based on the previous analysis of brake drum damage, it can be concluded that the observed damages affect the operational capability of the component in different ways. Depending on the type and extent of the brake drum damage, a decision is made whether the brake drum needs to be replaced or whether repair is possible through appropriate maintenance measures.
