Root Cause Assessment of Welded Satellite Gear Carrier Failure in a Bucket Wheel Excavator

In this article are presented partial results of the failure analysis of a fracture of the welded support structure of a satellite planetary gear of the BWE wheel drive.

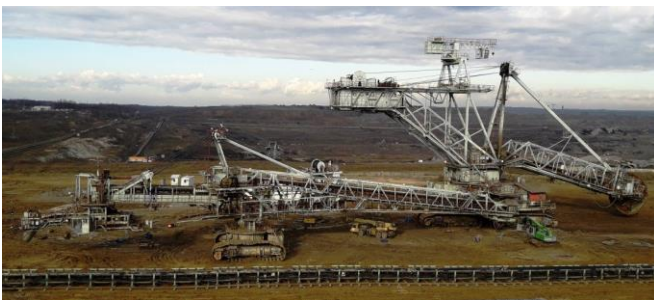
Fig. 1. Rotary excavator SRs 1300.26/5.0+VR±10

The excavator SRs 1300.26/5.0+VR±10, produced by "TAKRAF", Germany, is shown in Fig. 1, the cross-section of the reducer in Fig. 2, and the elements of the satellite carrier of the planetary part of the drive reducer in Fig. 3 (TAKRAF SRs 1300.26/5.0+VR±10, Equipment manufacturer's documentation).

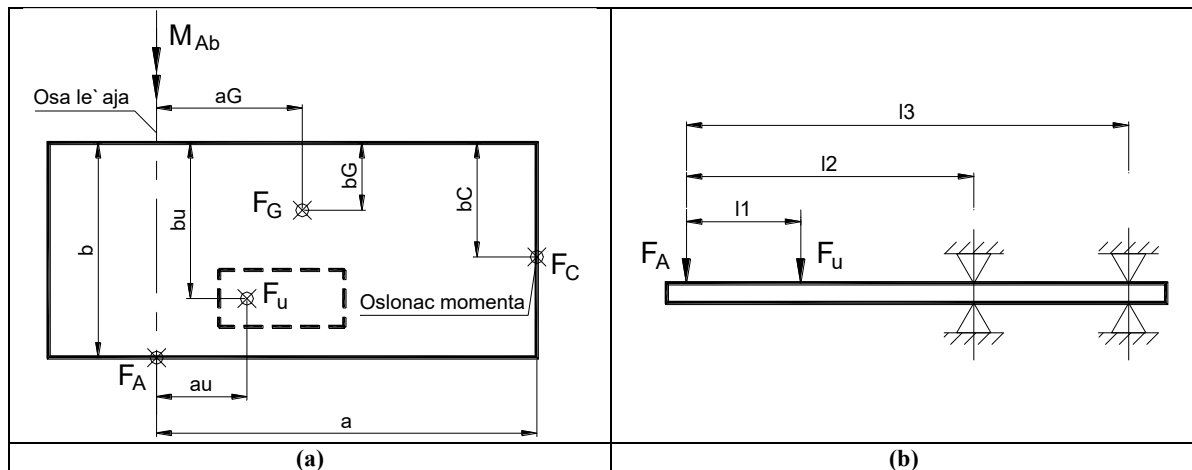
Fig. 6. (a) Gear box load display (top view); (b) Positioning and loading of the planetary shaft of the drive gear

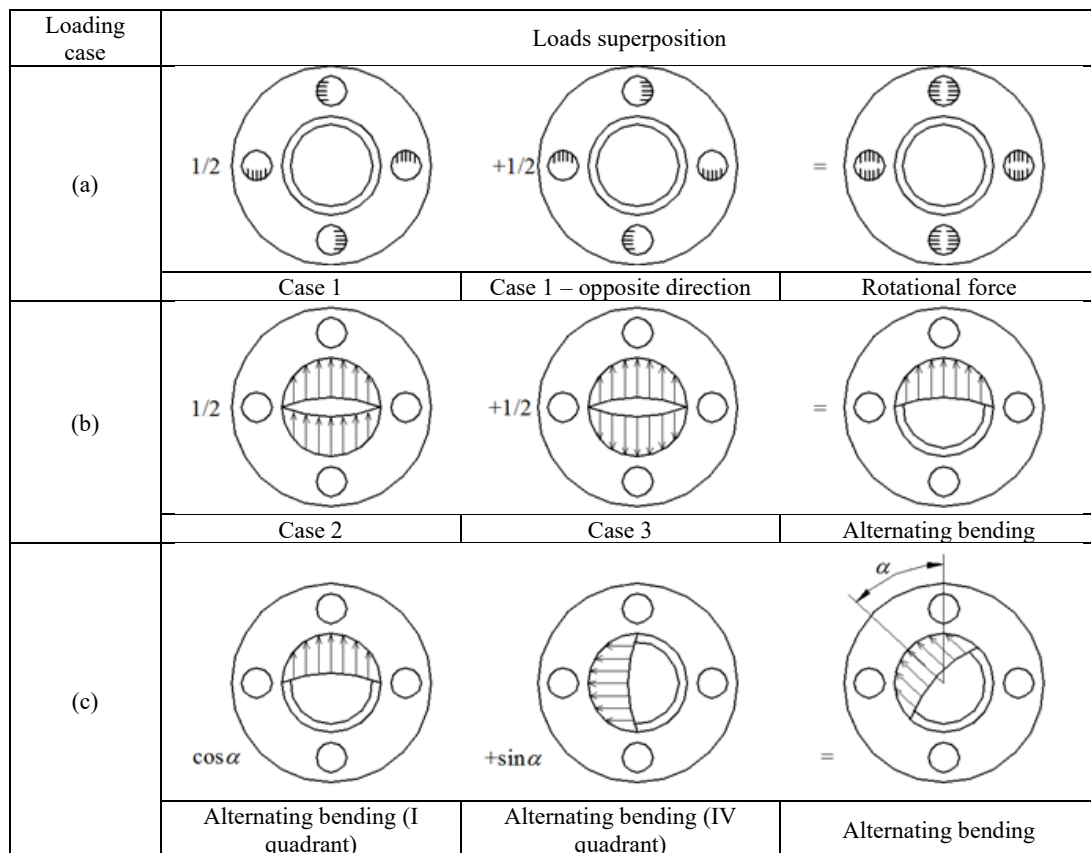
Fig. 8. Computational model of the load on the satellite carrier Computational model of satellite carrier load, superposition of loads due to: (a) rotational force; (b) own weight and alternate bending; (c) alternate bending

- Case 1, loading of the satellite carrier caused by rotational force,
- Case 2, loading of the satellite carrier caused by its self-weight and alternating bending,
- Case 3, satellite carrier loads caused by alternating bending.

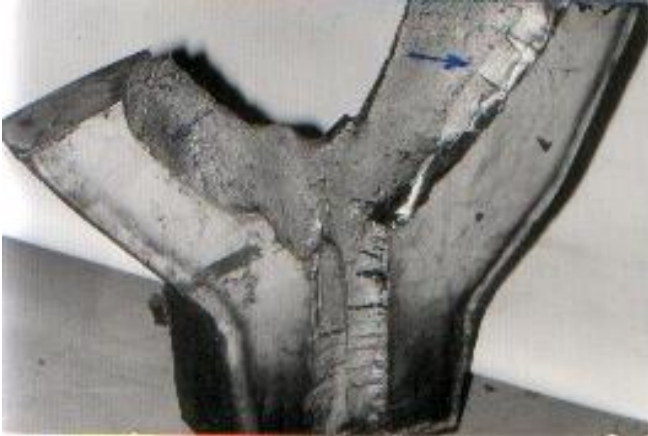
Fig. 10. The fracture surface of satellite carrier flange with indicated low-cycle fatigue (blue arrow)

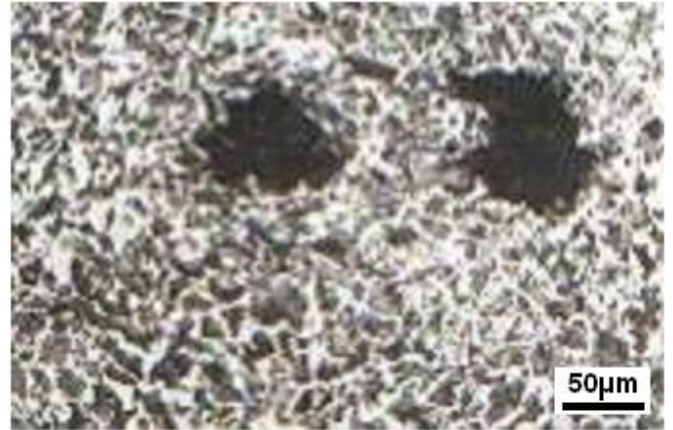
Scanning electron microscope revealed that the weld metal has a very heterogeneous structure with a large number of defects (bonding faults, cracks, inclusions, gas bubbles), Figures 11-13.

Fig. 13. The gas bubbles in the weld metal
