INVESTIGATION OF POSSIBLE CAUSES FOR APPEARANCE OF A CRACK IN THE WELDED JOINT OF THE SHIP WINCH FRAME

Miloš M. Matejić¹, Ružica R. Nikolić^{1, 2,*}

An appearance of a very unusual crack in the ship winch frame, which happened during the FAT, is described in this paper. The simulation by the FEM was performed to obtain the stresses at which the crack appeared. The possible causes for that crack appearance are considered. Some measures for reducing appearance of such cracks to a minimum are proposed, as well as certain directions for further research of this problem.

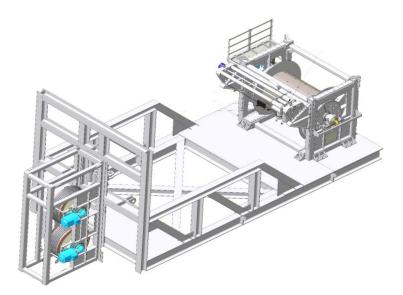
Factory acceptance testing (FAT) represents investigation of the winch prior to assembling it into the ship structure in conditions similar to real – operational ones. Test is done in such a way that winch stand is being welded onto the platform, identically as it is imbedded on the ship. After that, the tests are done to verify that the winding systems are operating properly. The load carrying capacity of the winch is tested in such a way that it is subjected to maximal calculated load, with additional 10 % of the variable load. The pulling force is then checked and so is the braking force. In Figure 1 is presented a sketch of the FAT station.

Fig. 1. The FAT station. (full colour version available online)

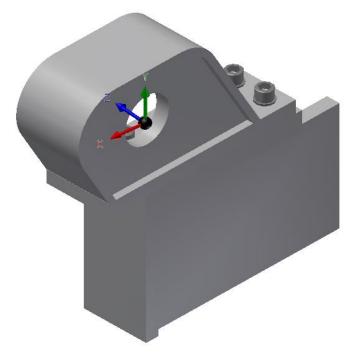
The part of the frame, together with the level wind support, was modeled. Those two welded assemblies were connected by screws, as in the original structure. Appearance of this model is given in Figure 3. The winch plates were 20 mm thick, except for the plate for connecting the level wind support, which was 30 mm thick. The level wind support's plates were also 20 mm thick, except for the support's housing plate, which is obtained by bending of the thin sheet, 10 mm thick. The connection between the frame and the support was done with four M 16 \times 40 screws with cylindrical heads.

Fig. 3. Assembly of the winch frame and the level wind support. (full colour version available online)
