RESEARCH OF THE POSSIBILITY OF REPAIRING BROKEN LAMINATED SPRINGS OF FREIGHT WAGONS BY WELDING

Dragan Petrović, Milan Bižić
petrovic.d@mfkv.kg.ac.rs, bizic.m@mfkv.kg.ac.rs

*University of Kragujevac, Faculty of Mechanical and Civil Engineering in Kraljevo,
Dositejeva 19, 36000 Kraljevo,
SERBIA*

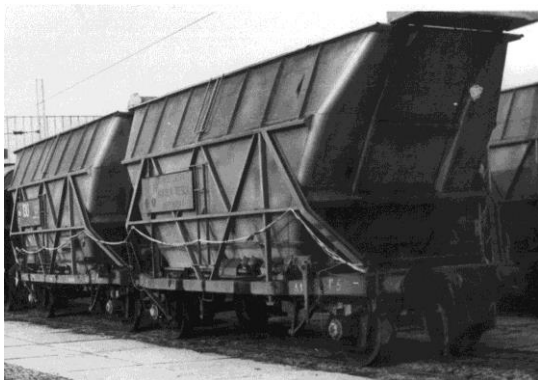
The 4-axled wagon Fbd consists of two 2-axle units that are interconnected by joint connection (Fig. 1). The gross wagon tonnage is 80 tons and it is primarily designed for efficient loading in the mining basin and unloading in the thermal power plant. For this reason, the design of wagon has specific solutions of body, underframe, and mechanisms for unloading. The floor of wagon is equipped with special door with the hydro-pneumatic drive, which provides automatic unloading and closing after that. Numerous mechanisms for opening and closing the door in the floor have reduced the space for placing of elements of suspension system. Because of these specifics, the design of suspension system which is based on LS departs from the standard design solutions. Reducing the length of LS in relation to standard solutions and very intense loadings in exploitation caused the increasing of stresses of elements of the suspension system. The steel limiter is fixed for the underframe of wagon and has the task to limit the stroke of LS (Fig. 2). In extreme operating conditions at maximum loads there are intense dynamic rigid impacts of spring buckle in the steel limiter which is very unfavorable for the suspension system and the underframe of wagon. As a result there were very frequent fractures of elements of suspension system and cracks on the underframe.

Figure 1. The Fbd wagon for coal transportation

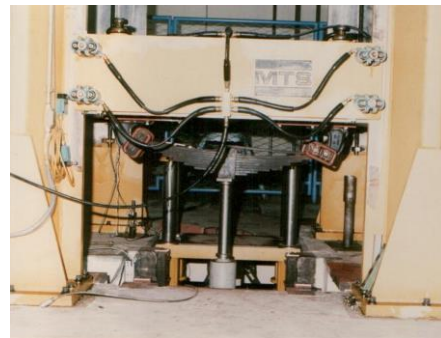
Figure 4. The dynamic testing of LS on the test stand of MTS production

The experimental tests were performed on pulsator, to the fracture of LS, with prescribed amplitudes and frequency. For this purpose, the test stand for dynamic testing of production “MTS” was used (Fig. 4). It is placed in the laboratory of the company “Prva Petoletka” in Trstenik, Serbia, and its main purpose is testing of landing gears of the aircrafts. In order to install LS and simulation of their real exploitation conditions, test stand was modified by the additional elements for introduction and acceptance of the load. The comparative tests were performed on the following LS: damaged LS with welded main leaf repaired in factory “Želvoz”, Smederevo (LS 1); damaged LS with welded main leaf repaired in factory “Gibnjara”, Kraljevo (LS 2); and completely new LS (LS 3). The testing program is designed in accordance with applicable international UIC standards for testing the static and dynamic strength of springs. It included the following tests: testing the geometric accuracy; identification of static characteristics; and dynamic fatigue testing to the fracture. The number of cycles and amplitudes of deflection of LS are defined in the regulations, and are presented in Table 1. The frequency of change of deflection amplitudes is defined in the regulations, and is equal 2 Hz.

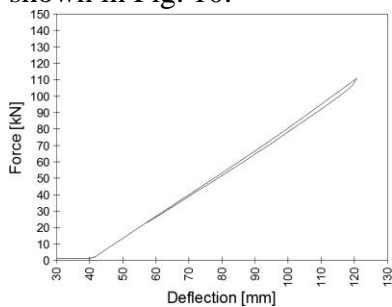
In the first step, the geometric accuracy of all three LS was tested. It is concluded that it is within the prescribed limits. In the second step, the static characteristics of LS 1, 2, and 3 were tested and recorded. It is concluded that deviation of static characteristics of LS with welded leafs (LS 1 and 2) from the static characteristic of not welded LS 3, is less than 1%. Of course, a similar deviation should be obtained in the case of all three LS whose leafs are not welded. Based on that, it can be concluded that all three tested LS have almost identically static characteristic. The diagram of static characteristic of LS is shown in Fig. 6. The example of changes of deflection and force in time, obtained during the fatigue tests of LS are shown in Fig. 7. The results obtained by experimental fatigue tests of LS 1, 2 and 3 are shown in Table 2.

Figure 6. The static characteristic of LS

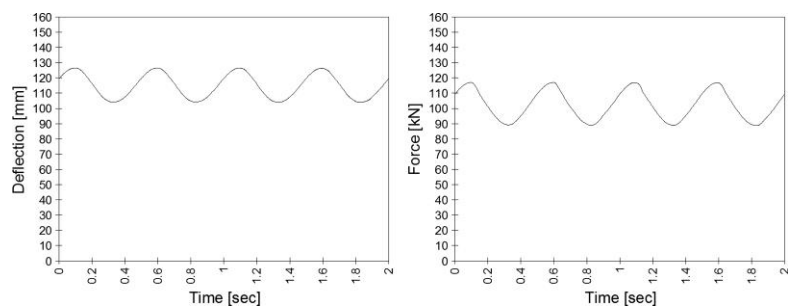
Figure 7. The change of deflection (left) and force (right) in time, obtained during the fatigue test of LS 2
