Fracture Analysis of the Hydraulic Truck Crane ATLAS 3006

Keywords: Hydraulic truck crane, Truck crane boom, Fracture analysis, FEM analysis

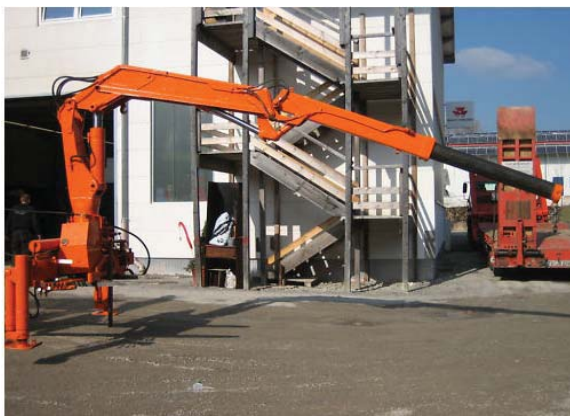
Figure 1. Hydraulic truck crane Atlas 3006

The hydraulic truck crane ATLAS 3006, which is the subject of research in this paper, is located at the Electricity Distribution Company Kruševac and is used for

work in very difficult conditions, for mounting and dismantling elements of power transmission lines and long distance lines so that it is mostly engaged for field work. The mentioned working conditions are difficult because it often lifts loads that are at the limit or exceed the values defined by the carrying capacity diagram. It is also used for tightening power lines, and there are no precise data about the values of forces that load the crane structure. The life and proper functioning of such a crane considerably depend on the operator himself, i.e. how much he adheres to the recommendations for its proper exploitation.

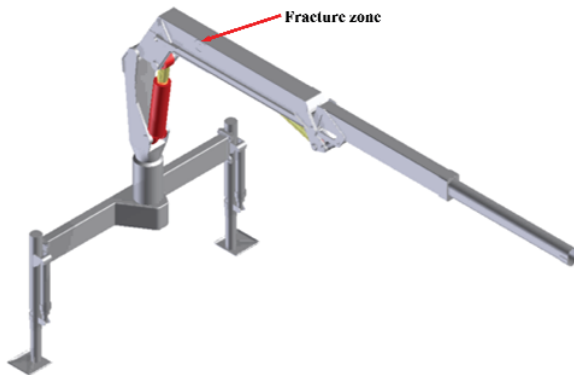
The analysis of the stress state of the hydraulic truck crane ATLAS 3006 was carried out by applying the finite element method (FEM). The model was formed on the basis of catalogue documentation and the additional measurements performed at the crane itself (Figure 4).

Figure 4. Model of the hydraulic truck crane ATLAS 3006

The 3D model of the hydraulic truck crane was built by synthesis of all structural parts (Figure 4). The model represents a continuum discretized by 10-node tetrahedral elements for the purpose of creating an FEM model (64036 nodes and 33060 elements). The first segment of the jointed boom of the truck crane was particularly taken out and analysed (Figure 5).

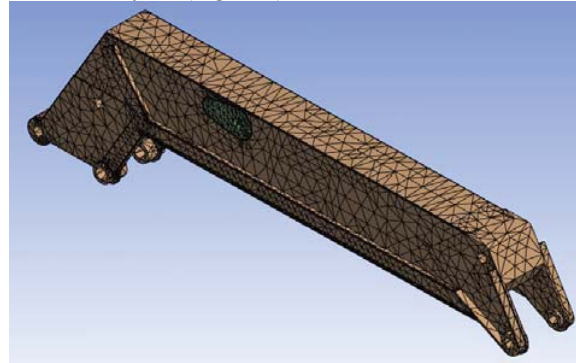
Figure 5. First segment of the boom of the hydraulic truck crane ATLAS 3006

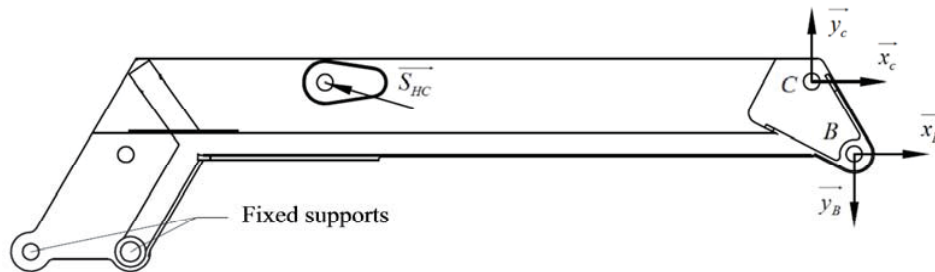
The manufacturer's data about the value of maximum load and the data about the mass of crane elements were used for the analysis of loads of the hydrocylinder support for lifting the second segment. The scheme of loading of the first segment of the crane boom is shown in Figure 6.

Figure 6. Scheme of loading of the first segment of the boom in the hydraulic truck crane ATLAS 3006

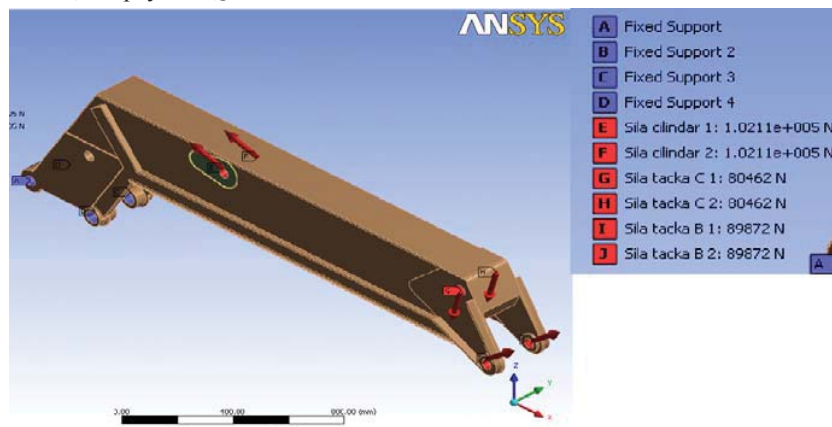
Figure 7. Scheme of loading of the first segment of the boom in the hydraulic truck crane ATLAS 3006

The obtained values of loads were used in the calculation model created in the software package ANSYS (Figure 7).
