DEGRADÁCIA KONŠTRUKČNÝCH MATERIÁLOV 2013

DETERMINATION AND ANALYSIS OF CAUSES FOR A CATASTROPHIC FAILURE OF A RESPONSIBLE MACHINE PART

Vukić Lazić¹, Srbislav Aleksandrović¹, Ružica R. Nikolić^{1,2}

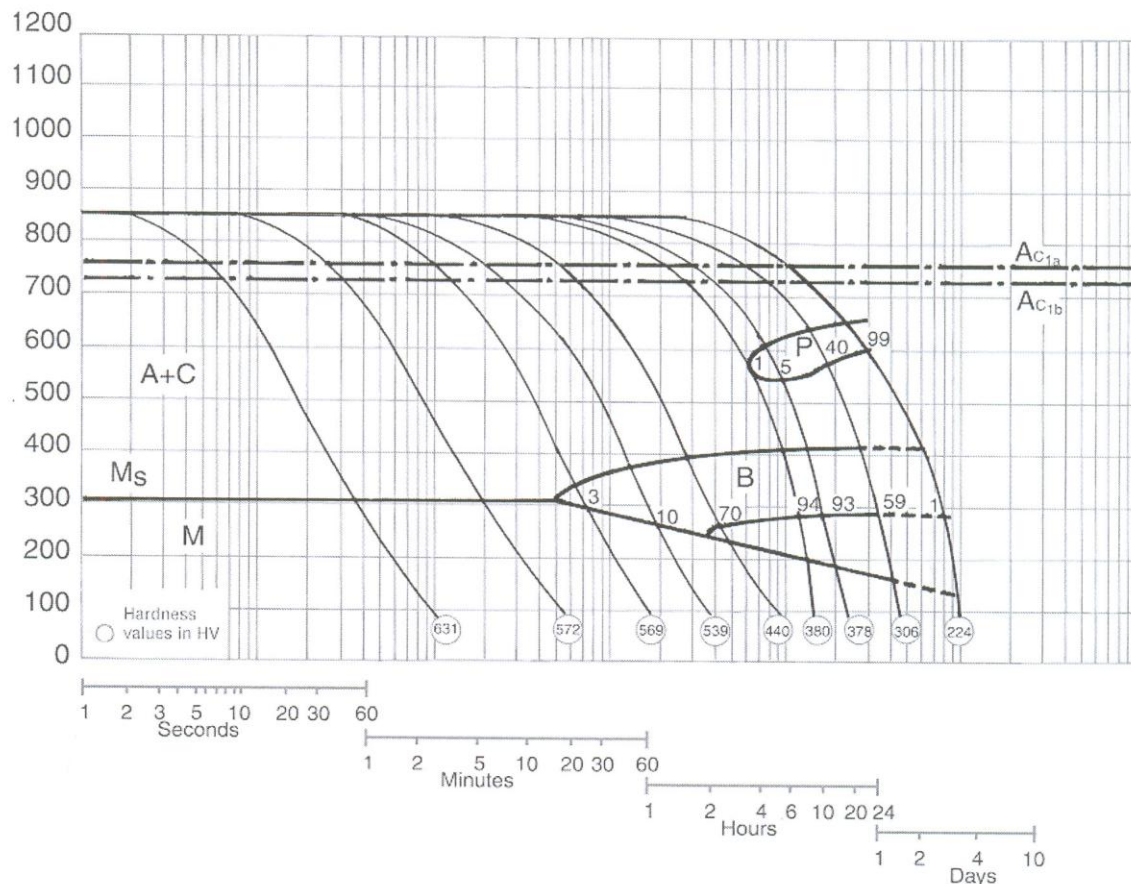
Fig. 1 Continuous-cooling transformation diagram for 40CrMnNiMo 8-6-4 steel

Heat treatment regimes were executed according to demanded requirements and the KH diagram of the under heated austenite decomposition (Figure 1) and the required hardness of the working piece [6, 7].

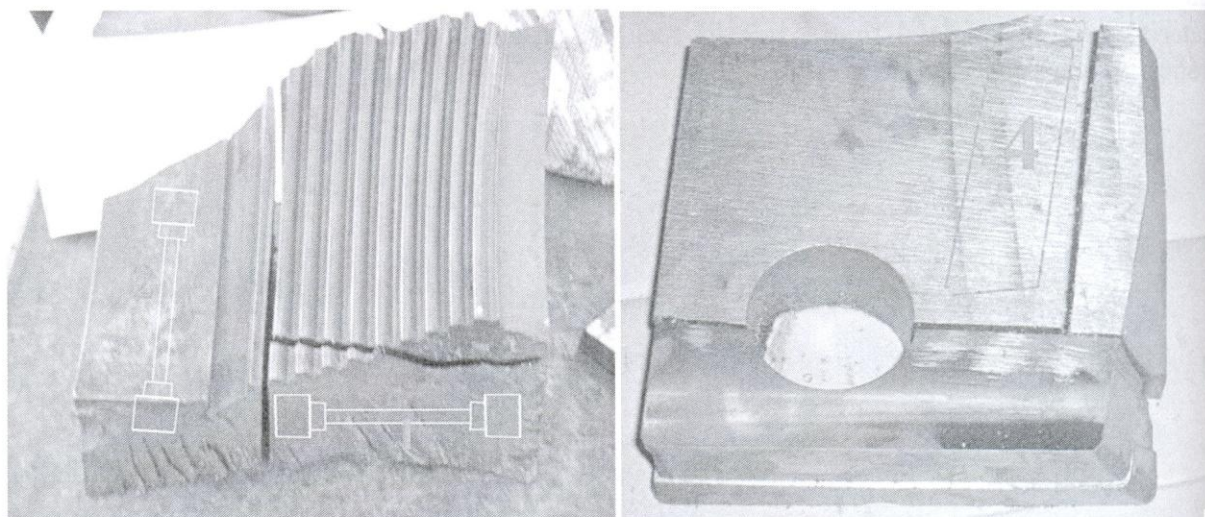
From the broken pieces (Figure 3) the samples were prepared for determination of the most important mechanical properties: impact energy at room and lowered temperatures (Table 6) and microstructure and hardness distribution.

Fig. 3 Places where the samples were taken from: for the tensile test (left) and for the microstructure and impact toughness determination (right).
