BOŠNJAK S, ARSIĆ M, SAVIĆEVIĆ S, MILOJEVIĆ G, ARSIĆ D. Fracture analysis of the pulley of a bucket wheel boom hoist system. *Eksploatacja i Niezawodność – Maintenance and Reliability* 2016; 18 (2): 155–163, <http://dx.doi.org/10.17531/ein.2016.2.1>.

FRACTURE ANALYSIS OF THE PULLEY OF A BUCKET WHEEL BOOM HOIST SYSTEM

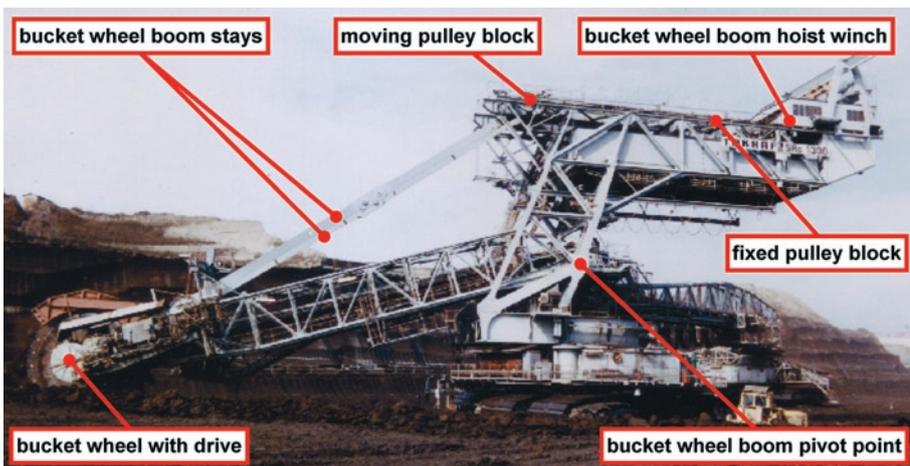
The bucket wheel boom (BWB) of the bucket wheel excavator (BWE) SRs 1300 (Fig. 1) is hung by two stays hinged to the trolley with the pulley block (the so-called "moving pulley block"). Changing of the BWB inclination angle is realized by shifting the moving pulley block.

Fig. 1. BWE SRs 1300: total weight 2303 t; theoretical capacity 4500 m³/h

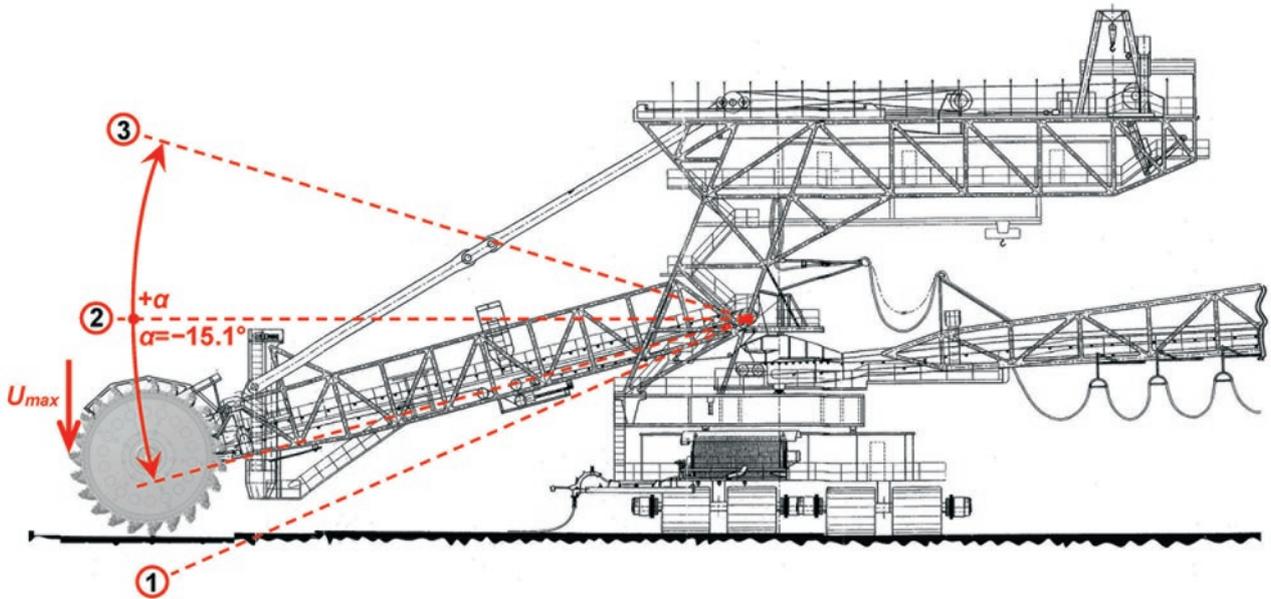
The load analysis of the BWE structure is very complex due to its changeable geometry configuration (Fig. 10).

Fig. 10. Characteristic BWB positions: 1 – low, $\alpha_{BWB}=-24^\circ 22''$; 2 – horizontal; 3 – high, $\alpha_{BWB}=16^\circ 34' 48''$ (U -cutting force)

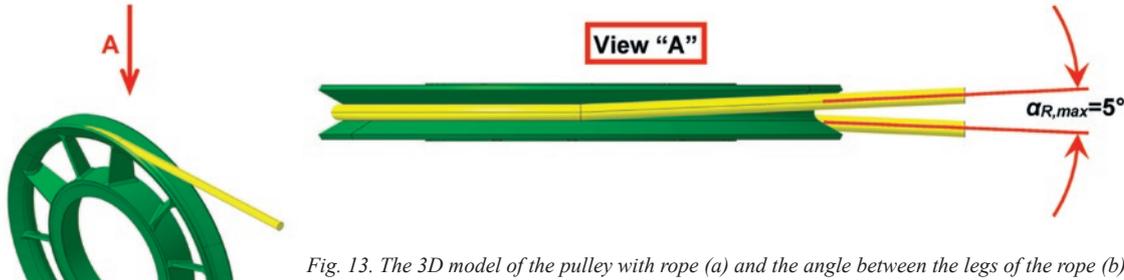
The stress state analyses are done by applying the finite element method (FEM). The 3D model of the pulley and rope (Fig. 13) was discretized by 10-node tetrahedron elements in order to create the FEM model (317,066 nodes, 185,852 elements, Fig. 14). Calculations are carried out for the maximum value of the angle between the legs of the rope $\alpha_{R,max}=5^\circ$ (Fig. 13b). Interaction between the

Fig. 13. The 3D model of the pulley with rope (a) and the angle between the legs of the rope (b)

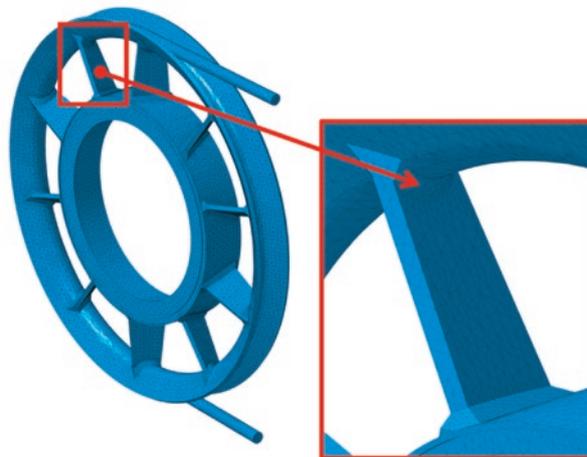
Fig. 14. The FEM model

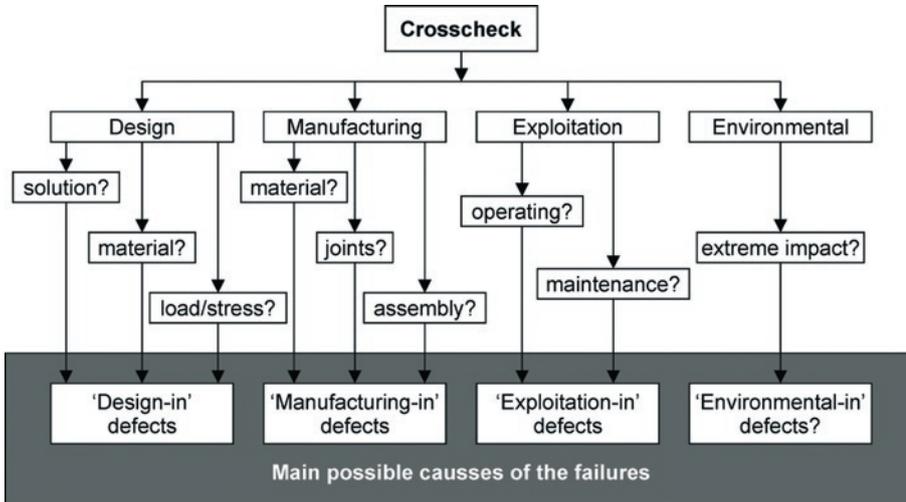
In order to make a decision on whether to repair or redesign the pulleys, it was necessary to conduct a complex procedure whose basic stages are shown in Fig. 16.

Fig. 16. The procedure of determining the causes of pulley fracture

Based on the presented results, it was concluded that the pulley fracture was caused by the ‘manufacturing-in’ defects. That is why it was decided to carry out the repairs of the pulley spokes’ welded joints, without modifying their design.
