# Exploitation Characteristics of Teeth Flanks of Gears Regenerated by Three Hard-Facing Procedures

**Keywords:** regeneration; gear; hard-facing; hardness; microstructure; hereditary properties

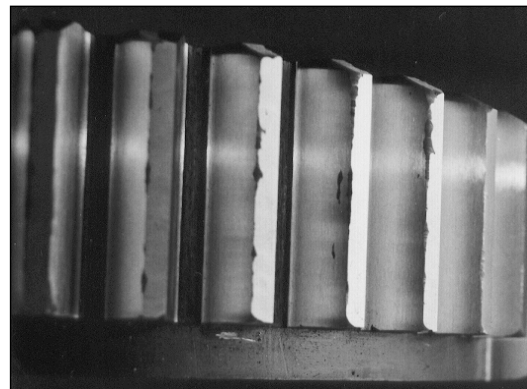
**Figure 3.** Appearance of the tooth regenerated by hard-facing.

Hard-facing of teeth was done in two passes. In the first pass (I), the tooth base and part of the head were hard-faced, while, after removing the slag, in the second pass (II), the remaining portion of the tooth head was hard-faced. The appearance of the tooth after the hard-facing, heat treatment and machining is shown in Figure 2c. During the hard-facing, it was taken into account that the thickness of the weld must be increased by the size of the additions for the intended subsequent machining. The appearance of the gear regenerated by the hard-facing is shown in Figure 3.
