INTEGRITY ASSESSMENT OF AN AIRCRAFT CYLINDER ASSEMBLY WITH A CRACK

Nikola Vučetić^{1*}, Gordana Jovičić², Ranko Antunović¹, Sandra Sovilj-Nikić³, Aleksandar Košarac¹, Dejan Jeremić¹

Keywords: crack, aircraft cylinder head, stress intensity factor, integrity assessment

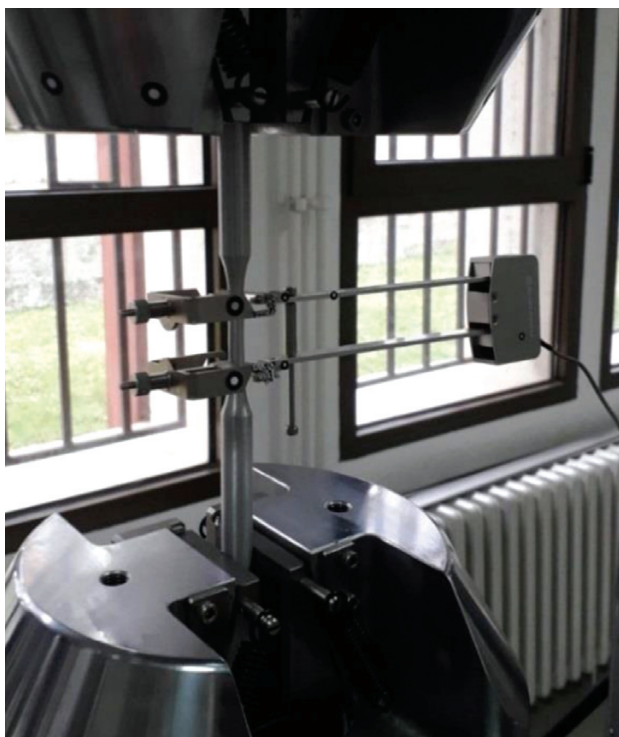
Dynamic Testing of the Faculty of Engineering, University of Kragujevac, on a SHIMADZU servohydraulic pulsator/shredder, type EHF-EV101K3-070-0. The test was performed at room temperature, including the control of displacement increment corresponding to the static load conditions for fracture and in accordance with standards B 557M and ASTM E646-00 (Figure 2).

Figure 2: Determination of the tensile strength at room temperature

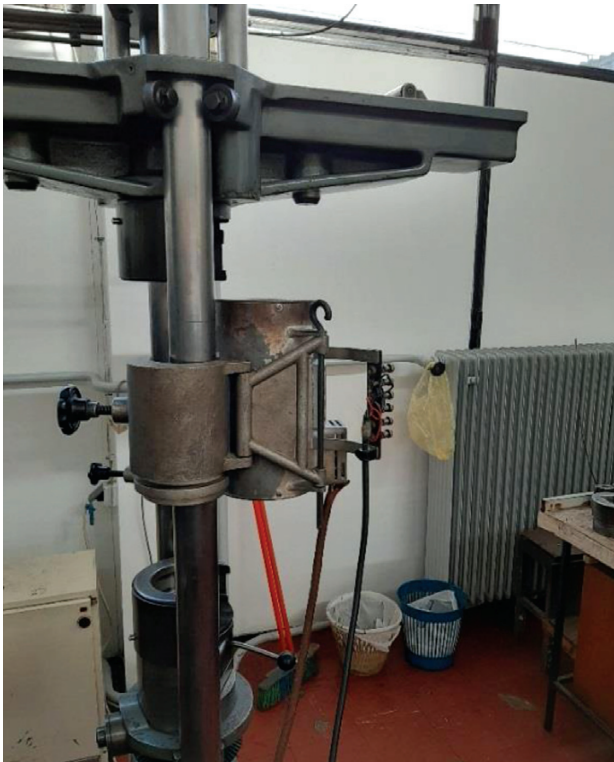
The testing of the tensile strength was performed on a universal hydraulic machine for static testing, Amsler, type 20 SZBDA (Figure 3). First, a test specimen was placed in the heating chamber of the above machine with the temperature set to 200 °C. After reaching the desired chamber temperature the test specimen was, according to

Figure 3: Determination of the tensile strength at elevated temperature

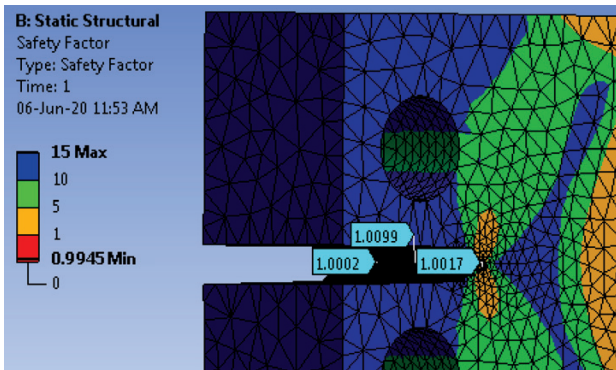
For the numerical simulation, the back surface of the CT specimen was fixed. The upper and lower surfaces of the specimen were subjected to a load in the vertical direction so that the specimen was tension loaded to such an extent that the safety factor at the crack front had a value of approximately 1 (**Figure 5**). This was the moment when the measure of stress concentration in the vicinity of the crack tip had such a value that it was on the verge of causing its propagation, i.e., the obtained stress

Figure 5: Safety factor at the crack front

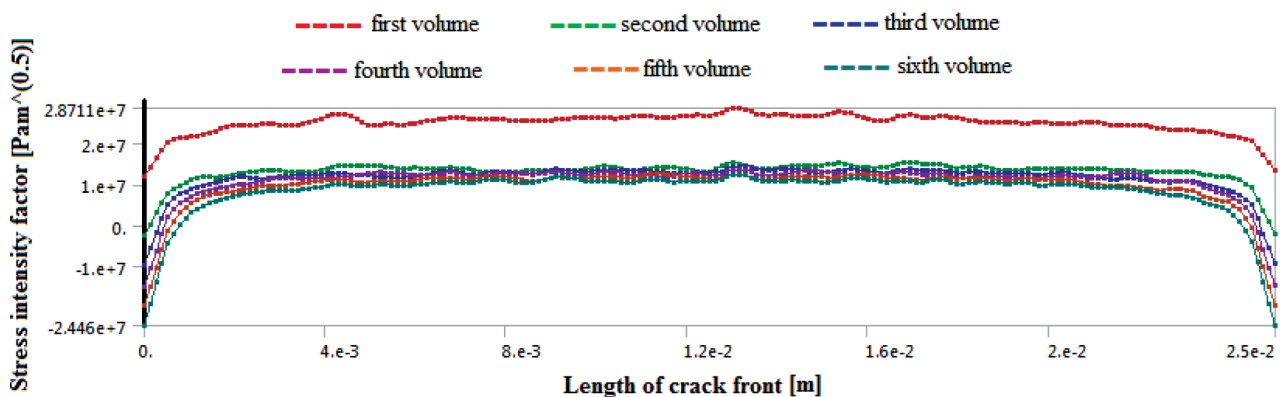
Figure 7 shows a diagram of the critical values of the stress intensity factor for the CT specimen for six volumes of J-integral integration for Mode I of the crack opening.

Figure 7: Diagram of critical values of stress intensity factor for Mode I of the crack opening

For the analysis of crack stability determination discussed in the following section, the mean value of all integration volumes from Figure 7 was adopted so that for Mode I of the crack opening, it is 16.25 MPa·m^{1/2} representing the critical value of stress intensity factor of the aluminum casting alloy of grade 242.0.

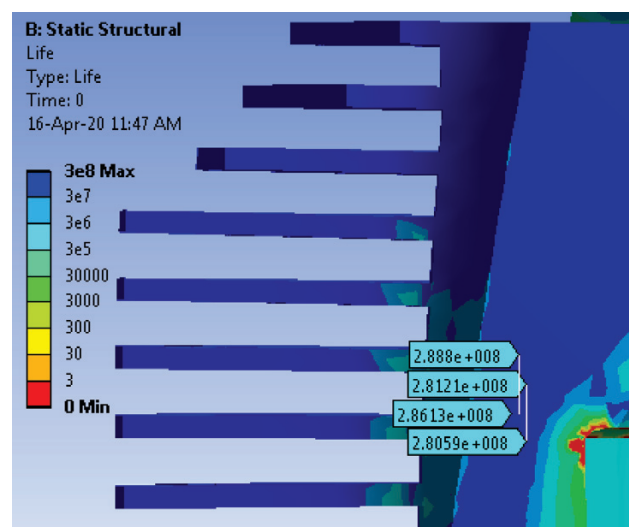
The testing of the stability of the defined crack was performed under a thermomechanical load and boundary conditions defined in previous research.¹⁵ Figure 10 shows the lifetime of the cylinder head with a 1-mm-long crack.

It is clear that the minimum number of cycles to failure applies to the vicinity of the crack tip. The lifetime of the rest of the cylinder head ranges from 2.80×10^8 to 2.98×10^8 cycles, which corresponds to the lifetime of

Figure 10: Lifetime of the cylinder head with a 1-mm-long crack

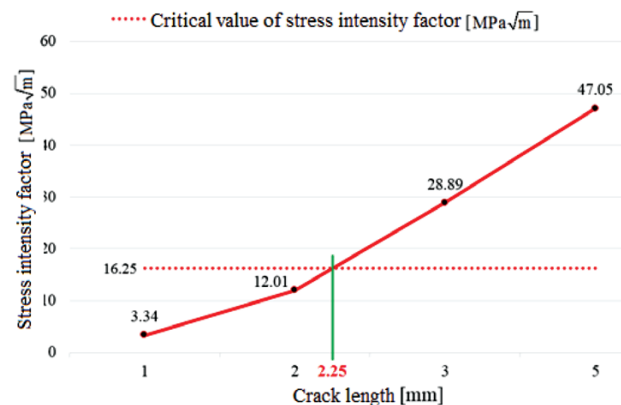
In order to test the resistance to breakage of the cylinder head, the values of stress intensity factors for cracks of different lengths were investigated. The dependence of the stress intensity factor on the crack length is shown in Figure 13.

From the above diagram, it can be seen that with the crack growth from 2 mm onwards the value of the stress intensity factor increases. The values of the stress intensity factor in the presence of 1-mm and 2-mm-long crack in the cylinder head are $3.34 \text{ MPa}\cdot\text{m}^{1/2}$ and $12.01 \text{ MPa}\cdot\text{m}^{1/2}$, respectively. Taking into account that the critical value of the stress intensity factor is $16.25 \text{ MPa}\cdot\text{m}^{1/2}$ it is concluded that a crack length of 2.25 mm is considered the critical crack length so that the cylinder head is a stable structure in terms of further

Figure 13: Dependence of the stress intensity factor on the crack length

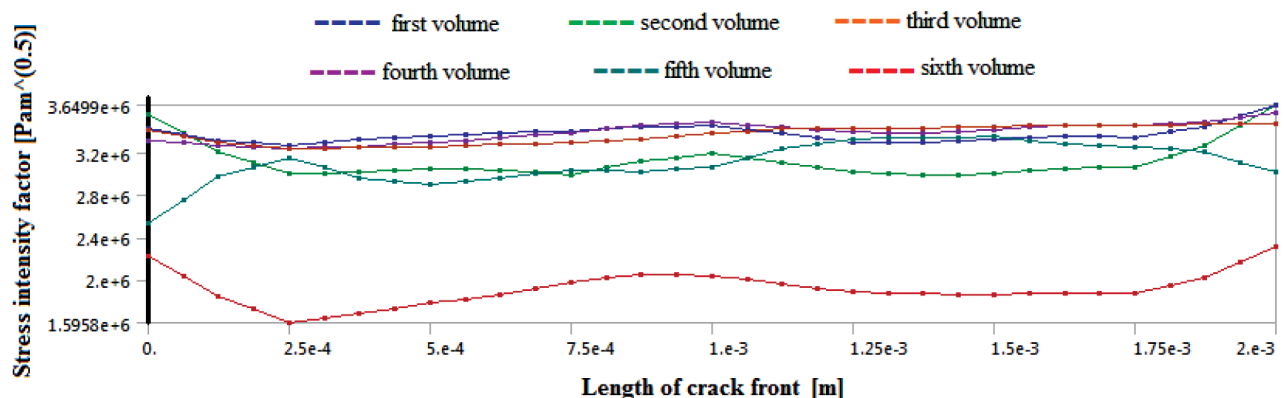
Figure 12 shows a diagram of the values of the stress intensity factor for six analyzed volumes of integration. For further crack stability analysis, a mean value of all integration volumes of $3.34 \text{ MPa}\cdot\text{m}^{1/2}$ was adopted.

Figure 12: Diagram of values of the stress intensity factor for a 1-mm-long crack
