# WEAR RESISTANCE OF LAYERS HARD FACED BY THE HIGH-ALLOYED FILLER METAL

Dušan Arsić<sup>1</sup>, Vukić Lazić<sup>1</sup>, Ružica Radoslava Nikolić<sup>1,2,\*</sup>, Milan Mutavdžić<sup>3</sup>,  
Srbislav Aleksandrović<sup>1</sup>, Milan Djordjević<sup>1</sup>

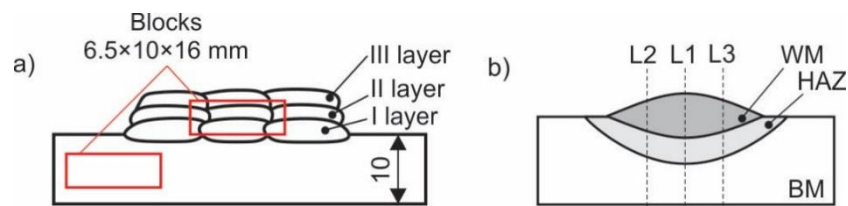
Fig. 1. Layer deposition and block for tribological testing (a) and metallographic sample (b); L1, L2 and L3 denote the directions of hardness measurements.  
(full colour version available online)

Hardness was measured on samples prepared according to Fig. 1 and it was used to form curves of the hardness distribution in the three characteristic parallel directions (L1, L2 and L3). Besides that, the characteristic microstructures were recorded in the three zones of the hard faced layer – in the weld metal (WM), heat affected zone (HAZ) and in the base metal (BM). Etching of samples was done in two phases. In the first phase, samples were etched by the 3 % Nital solution (in denatured alcohol) and after that, only the zones of the BM and the HAZ were visible. Then, in the second phase, the samples were etched by the 4 % Vilelle solution. This solution is very aggressive and it can provide good quality etching of the highly alloyed hard faced layers. Results of the hardness measurements and the microstructures of the individual hard faced layer's zones are presented in Fig. 3.

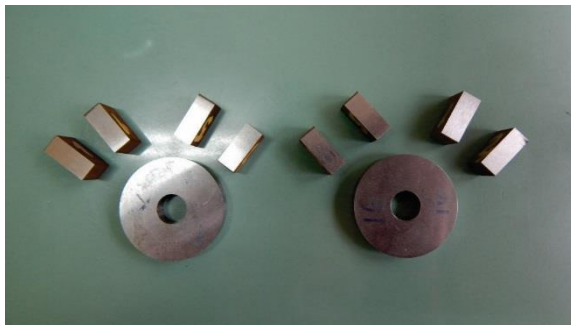
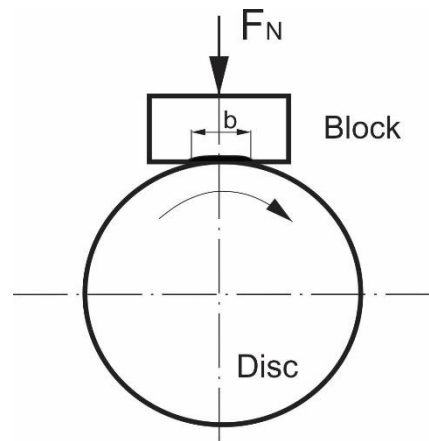
a) prepared blocks and discs

b) block-on-disc contact scheme

Fig. 2. Prepared blocks and discs and block-on-disc contact scheme.  
(full colour version available online)

Tribological test assumed subjecting the samples, cut-out from the hard faced layers and the BM, to the wear test on the tribometer with the block-on-disc contact (Fig. 2).

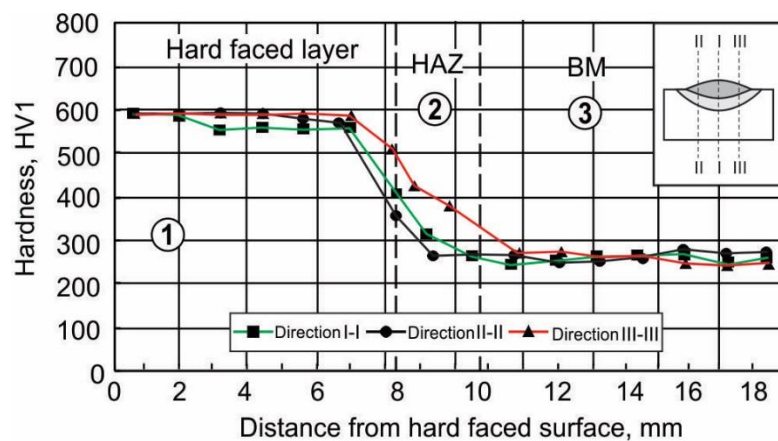
Fig. 3. Hardness distribution (diagram above) and the microstructures of the WM (1), HAZ (2) and BM (3) pictures (below).

From the graph in Fig. 3 one can see that the hard faced layer hardness is about 600 HV1, what corresponds to the data provided by the manufacturer. It can also be noticed that hardness was maintained over the whole cross section of the hard faced layer (average thickness of about 7 mm), after which it drops within the HAZ and the BM.

The BM microstructure was estimated as ferritic-perlite, while the microstructure of the FM was ledeburite–cast structure with excreted carbides. They possess the high hardness what should ensure the improved wear resistance.

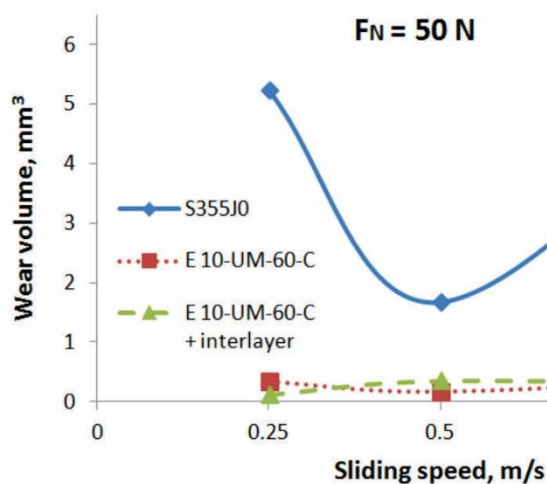
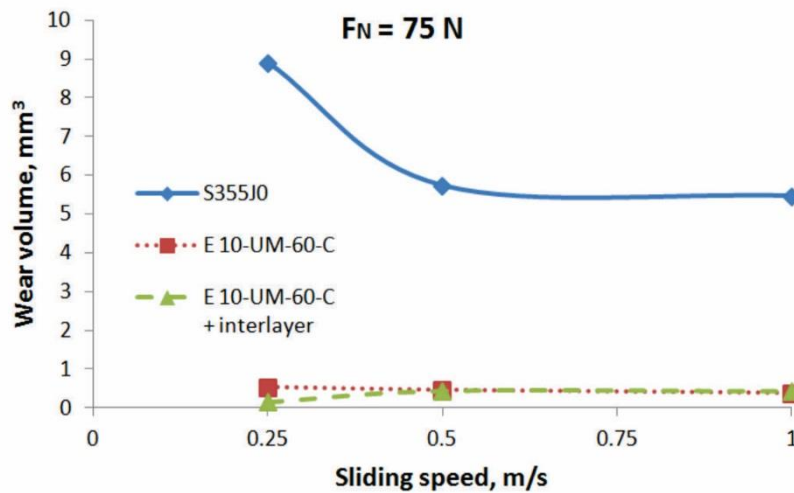
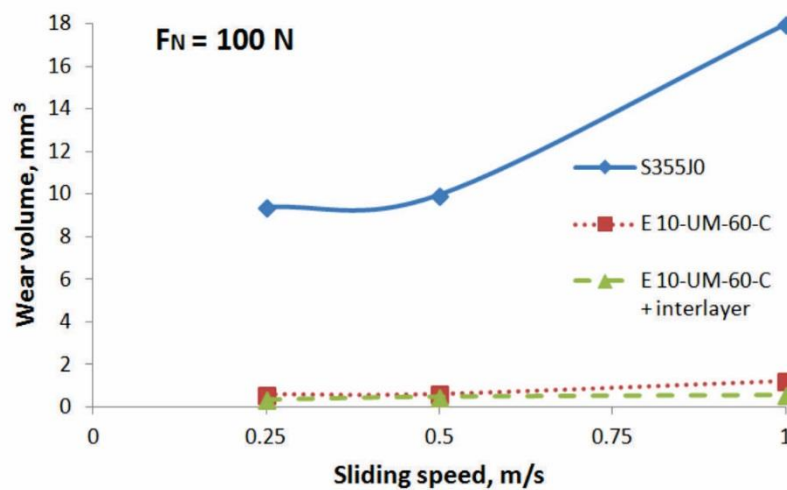
a) 50 N

Fig. 4. Worn material volume at different loads and histogram of the friction coefficient average values for all the loads and sliding speeds.

b) 75 N

c) 100 N

Obtained results show that the hard faced layers possess significantly higher wear resistance than the base metal, as it was expected. The curves in Fig. 4 show increase of the worn material mass with increase of the sliding speed and the normal loading, all the way up to reaching the highest degree of wear at maximum load of 100 N and at the highest speed of 1 m.s<sup>-1</sup> (Fig. 4c), what was also confirmed by some other investigations [17, 20].

However, it is interesting that almost the same results were obtained for the case of the applied force of 75 N at sliding speeds of 0.5 and m.s<sup>-1</sup> (Fig. 4b). This means that increase of speed from 0.5 to 1 m/s, at that load does not have any influence. In addition, results show that at the loading force of 50 N, the optimal sliding speed 0.5 m.s<sup>-1</sup>, since the wear is the least (Fig. 4a). Results have also shown that there is no big difference in wear behavior between samples with and without austenitic interlayer (Table 2 – sample #3 has even somewhat higher resistance), what means that the interlayer can be used whenever it is necessary and that would not influence the wear resistance of the hard faced layers.

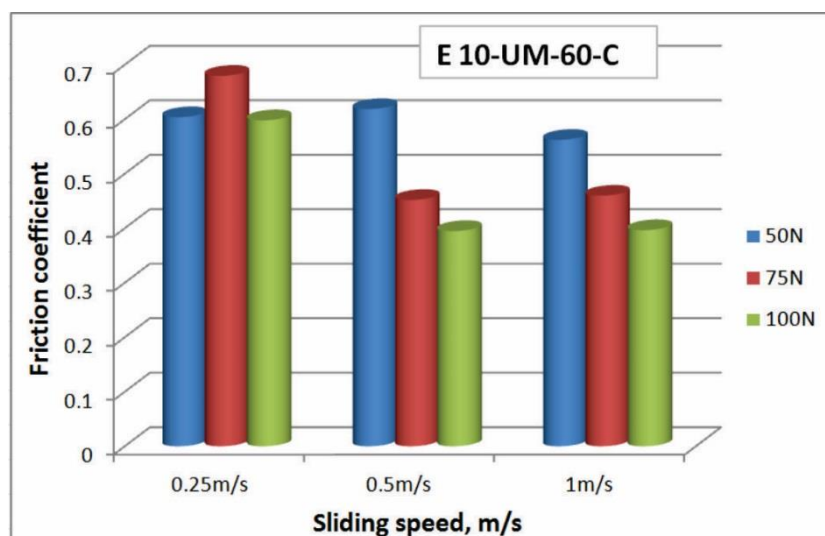
d) histogram of the friction coefficient average values for all the loads and sliding speeds  
 Continuing of Fig. 4. Worn material volume at different loads and histogram of the friction coefficient average values for all the loads and sliding speeds.  
 (full colour version available online)

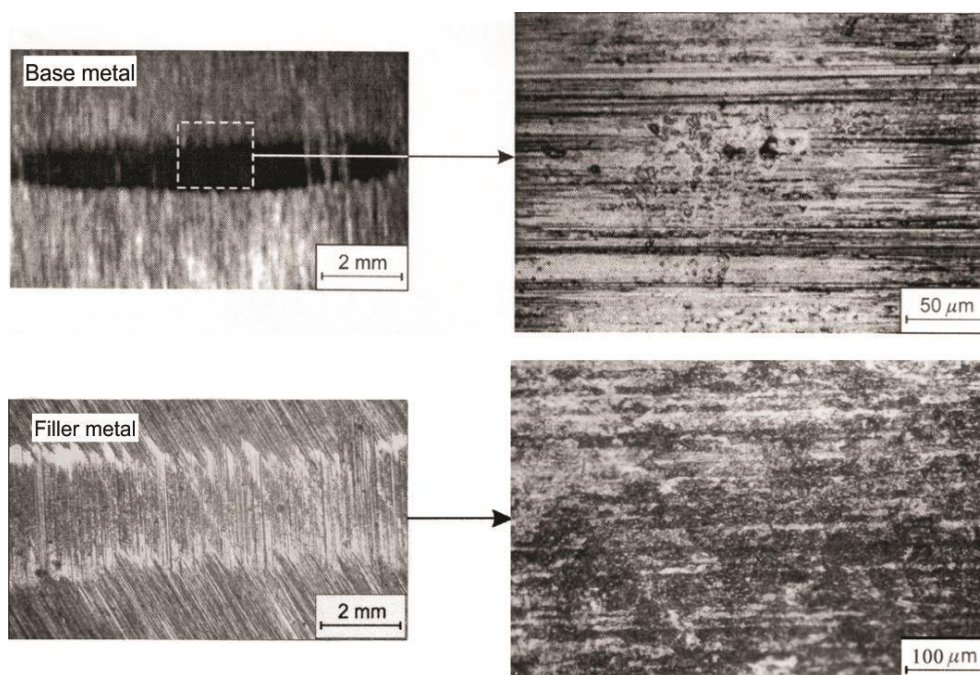
Fig. 5. Macroscopic (left) and microscopic (right) appearances of the damaged blocks of the hard faced layers.

Photos in Fig. 5 show the characteristic damages of the tested materials surfaces. The characteristic phenomena in the initial stadium of wear are appearances of crevices and wear scars. However, after a certain distance,

at the crack sites material particles started to detach from the sample's surface, usually due to adhesion to disc material [20]. Those particles can later also act as the abrasive and induce further damages. The shown damages are in accordance with the results obtained for steel

S355J0 [22], verifying the fact that it possesses poor wear resistance. On the other hand, the hard faced sample exhibits the higher wear resistance and its wear scar is significantly smaller and there is no appearance of spots of the material detachments from individual zones.
